Deep Water Horizon Lecciones Aprendidas

Un Reporte de lo ocurrido con la Deepwater
Horizon

En la noche del 20 de abril del 2011, un evento de Well Control permitió que los hidrocarburos salieran del pozo Macondo sobre el semisumergible Deepwater Horizon de la empresa Transocean, resultando en explosiones y fuego en el equipo. 11 personas perdieron la vida, y otras 17 resultaron heridas. El fuego, que fue alimentado por los hidrocarburos que salieron del pozo continuó por 36 horas hasta que el equipo se hundió. Los hidrocarburos continuaron saliendo por el BOP por 87 días, causando un derrame de significancia mundial.

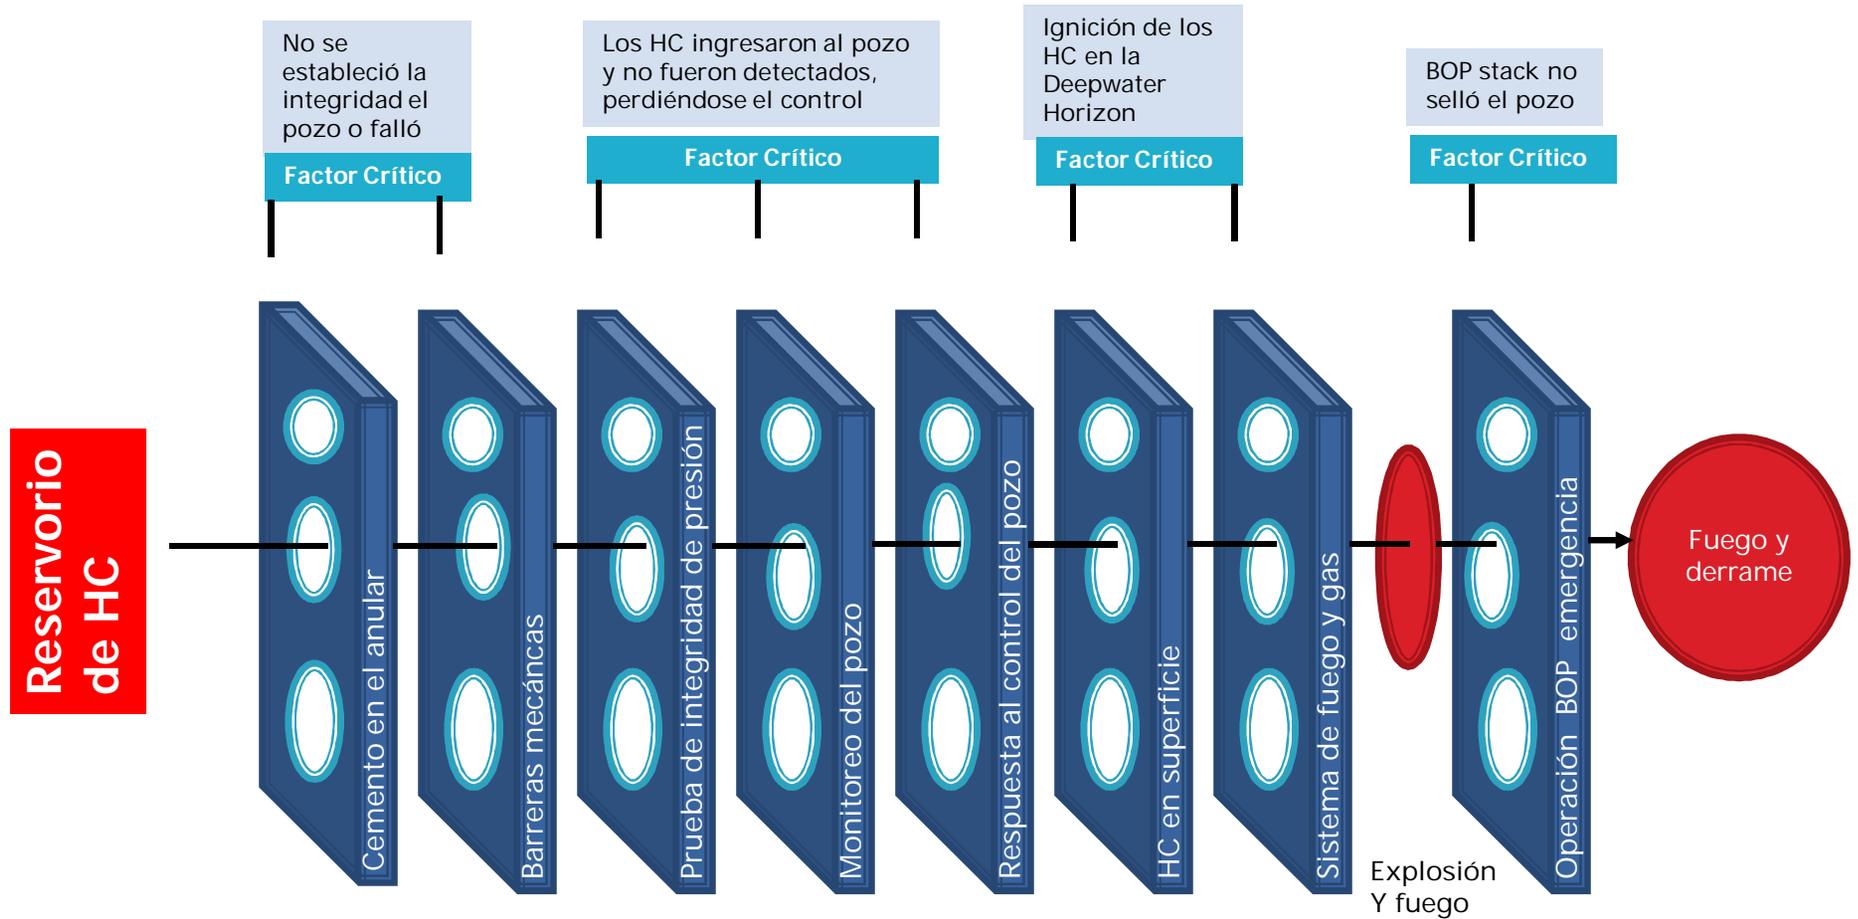
Figura 1. Barreras que no funcionaron y la relación de las barreras con los factores críticos.

- I. **No se estableció la integridad del pozo**
 - 1) La barrera de cemento en el anular no aisló a los HC
 - 2) La barrera del shoe track no aisló los HC
- II. **Los HC que ingresaron al pozo no fueron detectados y se perdió el control del pozo**
 - 3) La prueba de presión negativa fue aceptada aunque la integridad del pozo no se había establecido
 - 4) El influjo no fue reconocido hasta que los HC estuvieron en el Riser
 - 5) Las acciones de respuesta de control de pozos fallaron y no se pudo controlar.
- III. **Los HC se prendieron en la Deepwater Horizon**
 - 6) La línea de venteo del separador de gas iba al equipo
 - 7) No se previno la ignición del gas
- IV. **El BOP stack no selló el pozo**
 - 8) El BOP en modo de emergencia no selló el pozo

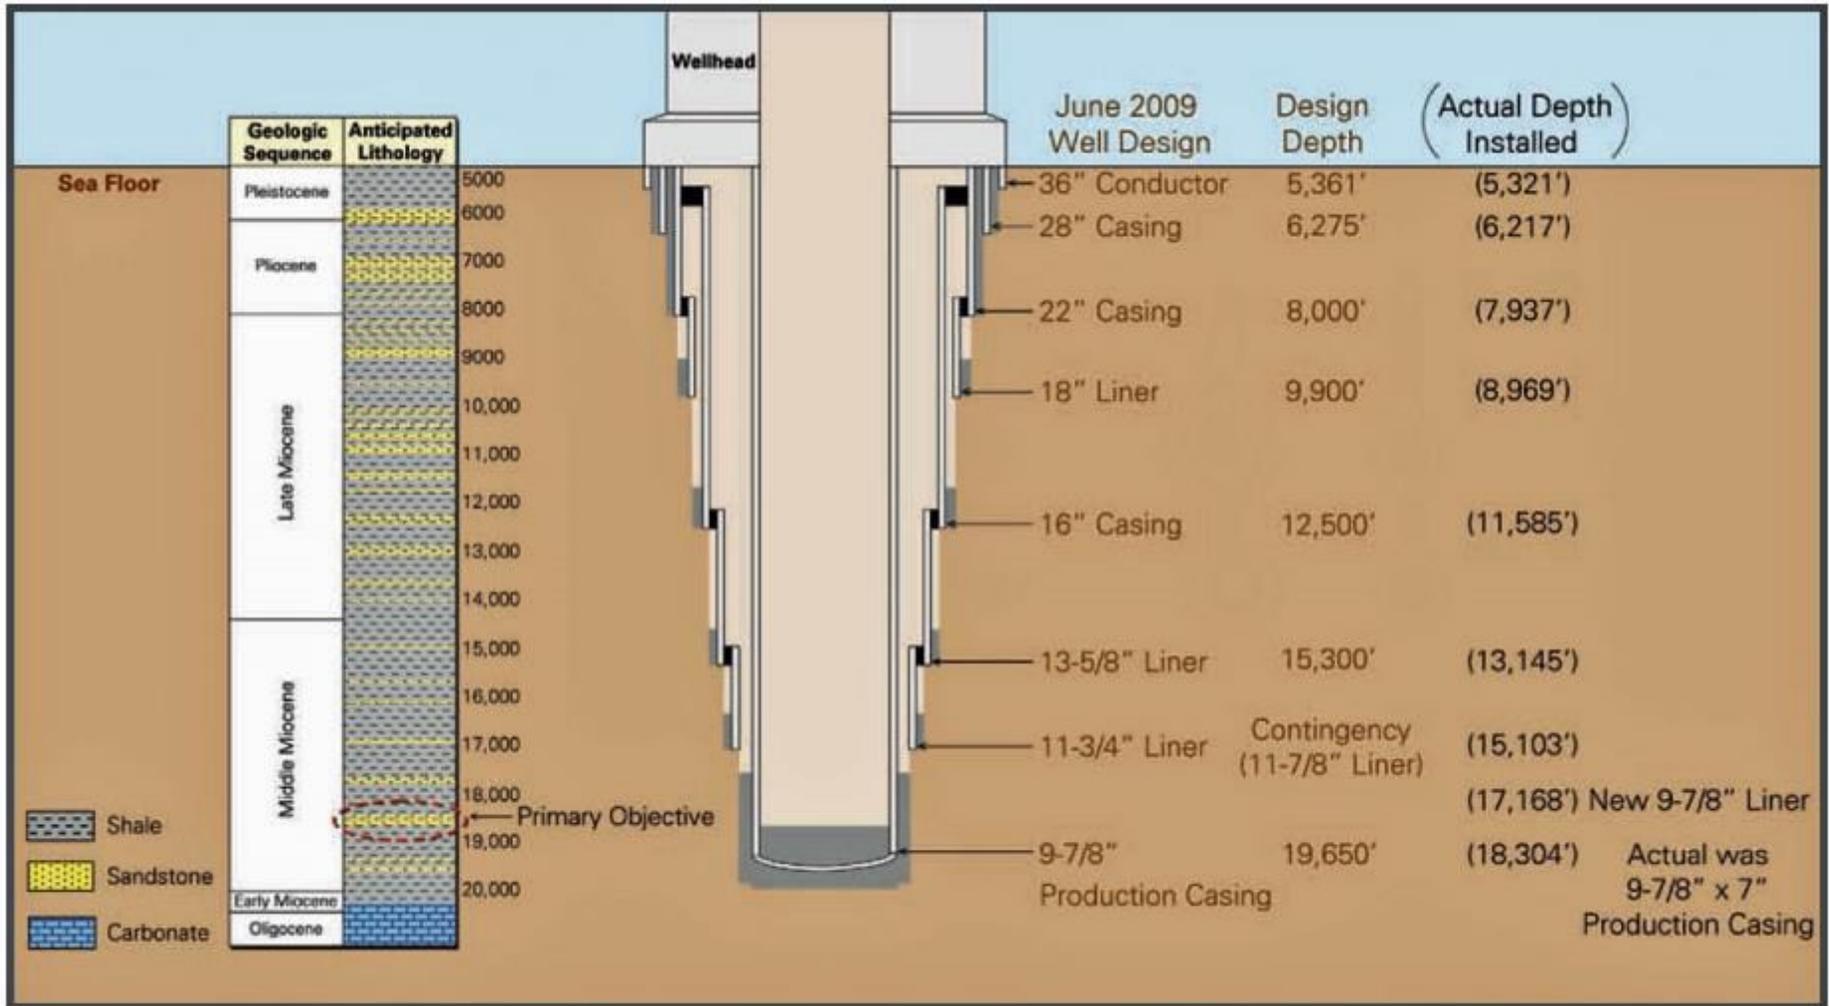
Figure 2. Geology, Original Well Design and Installed Depth.

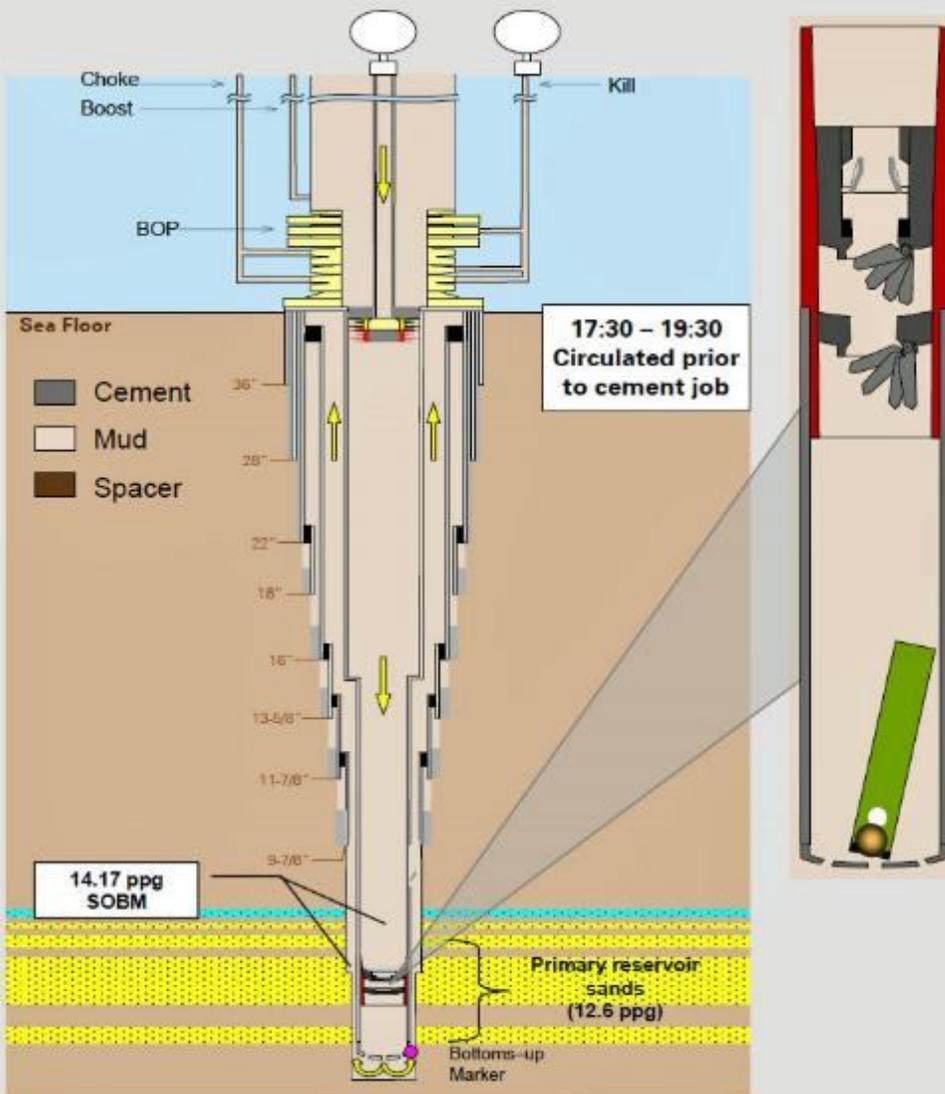
Después de perforar hasta el TD. Se baja el casing hasta el fondo y se prepara para realizar el trabajo de cementación. Un float collar con doble válvula se usa para prevenir un backflow o ingreso de fluidos a través del shoe track, hasta que el cemento esté duro y cree una barrera permanente.

- Casing largo y robusto, consistente con los pozos similares en el área
- 9 intentos para establecer circulación para convertirlas a float valves
- Circula ~6 veces el volumen de hueco abierto, a circulación limitada debido a probable pérdidas y washout en el pozo
- No hubo evidencias de que HC hayan ingresado al pozo antes de la operación de cementación

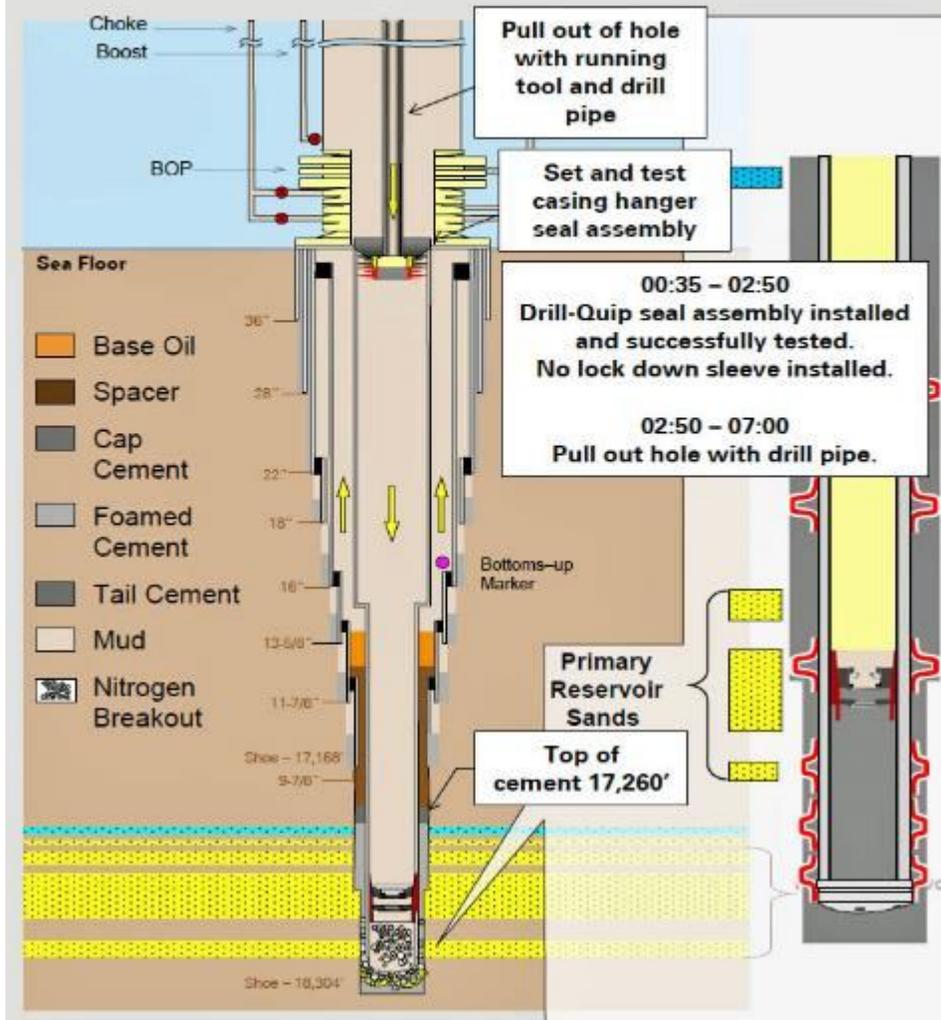
El cemento se bombea hacia el casing pasando por el float collar y hacia el anular para aislar las arenas del reservorio primario

- Se escogió una mezcla de cemento con nitrógeno
 - ❑ Para lograr una suspensión de peso ligero debido a una ventana de gradiente de presión de poro / gradiente limitada
- Riesgos posibles
 - ❑ Estabilidad de la espuma
 - ❑ Relativamente volúmenes pequeños
 - ❑ Susceptible a contaminación
- Mitigación del riesgo
 - ❑ Pruebas exhaustivas del diseño de la mezcla
 - ❑ Ubicación precisa
- Centralización
 - ❑ 6 centralizadores espaciados en las arenas
 - ❑ Centralizadores adicionales no se bajaron porque eran del tipo incorrecto
 - ❑ Riesgo de canalización encima de las arenas conocidas y aceptadas

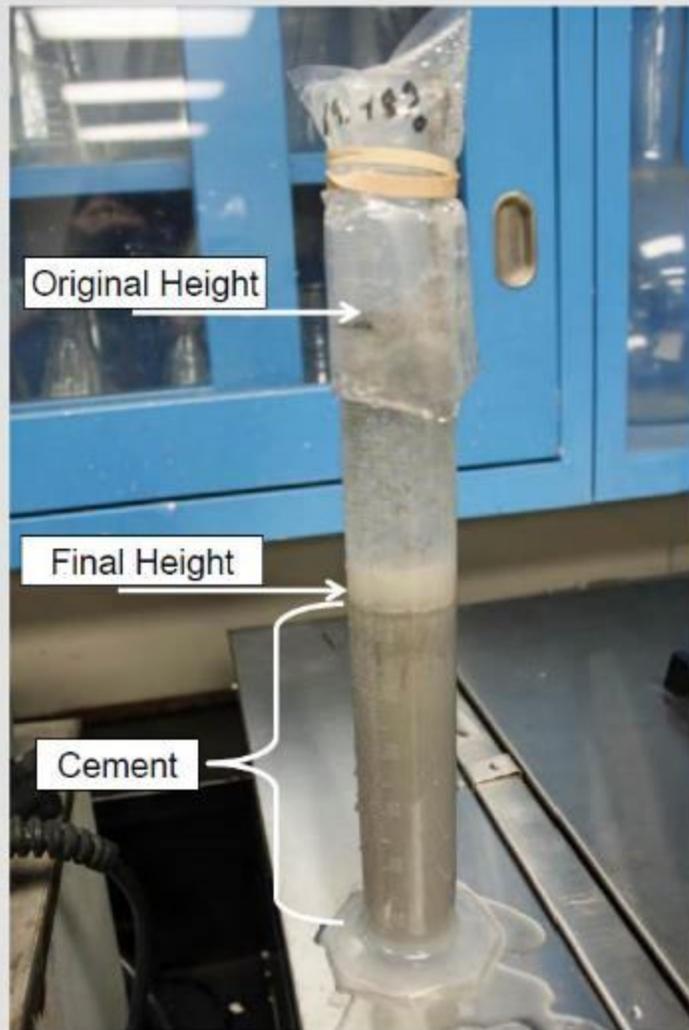
Unstable Foam Sample

Un laboratorio independiente, realizó 500 pruebas de la lechada de cemento y concluyó que:

- En el 50% la calidad de la espuma no era estable en condiciones de superficie
- En el 18.5% la calidad de la espuma a condiciones de fondo, no eran estables
- El Yield Point de la mezcla era muy baja para el cemento con espuma (2 lb/100ft² a 135° F)
- La pérdida de fluido para la base de la mezcla era excesivo comparado con las recomendaciones de la industria (302 cc versus 50 cc por 30 min)
- Nota: Calidad= Vol. De nitrógeno / (Nitrógeno + Vol. de mezcla base)

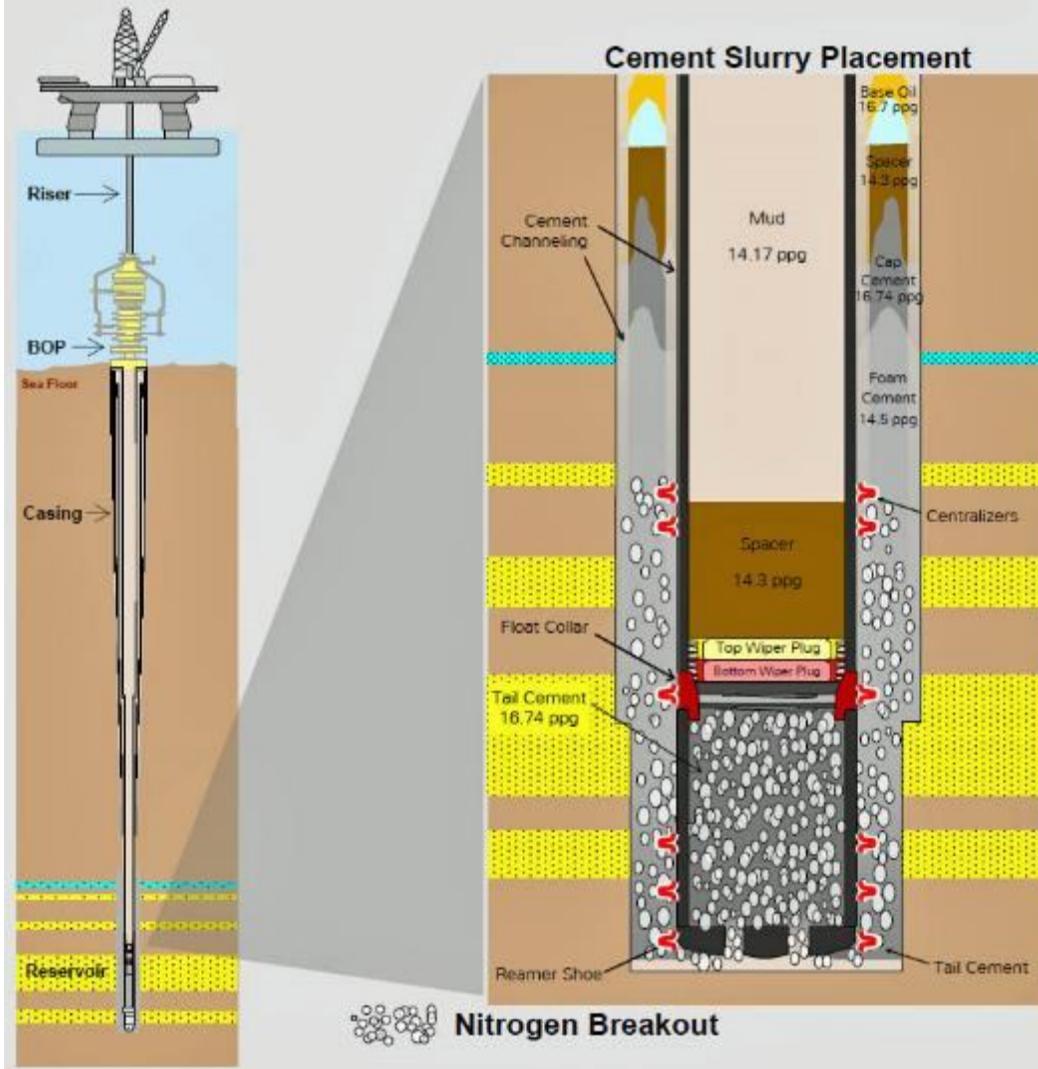
The annulus cement barrier did not isolate the reservoir hydrocarbons

El cemento se bombea dentro del casing, para luego quedarse en el espacio anular y aislar las zonas de arenas con HC

- La recomendación de la mezcla de cemento fue un diseño complejo
- Riesgo de contaminación usando pequeños volúmenes de cemento
- Sin aditivos para pérdida de filtrado
- Prueba en el laboratorio antes del trabajo, incompleta
- La mezcla del cemento era inestable
- Un registro CBL no fue corrido para evaluar el trabajo de cemento

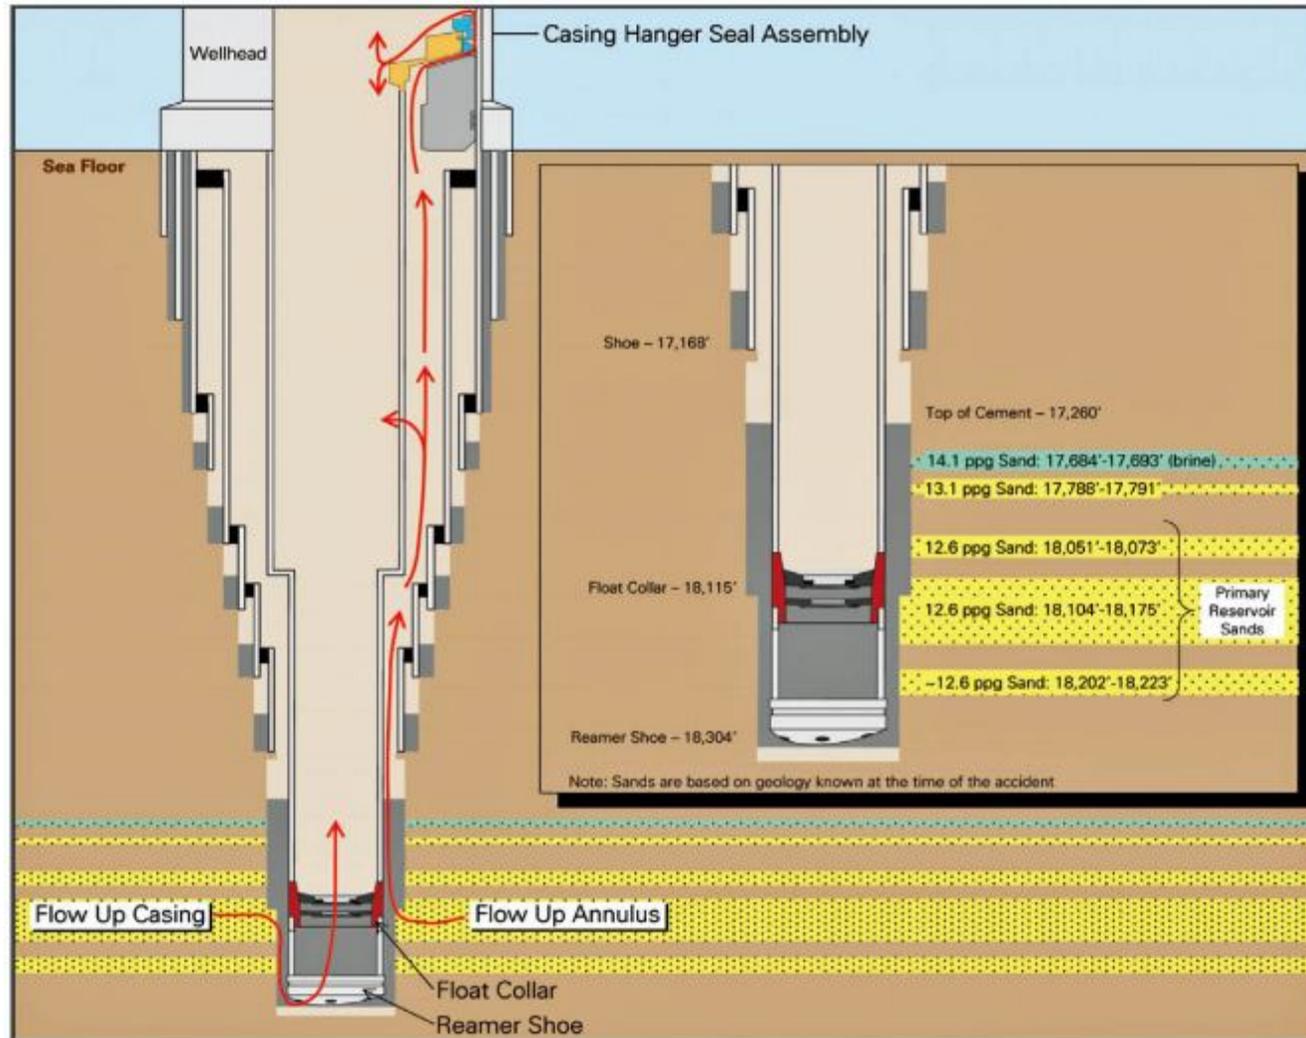
Por la evidencia disponible y análisis se concluyó que el influjo atravesó la barrera del shoe track

Figure 1. Hydrocarbon Zones and Potential Flow Paths.

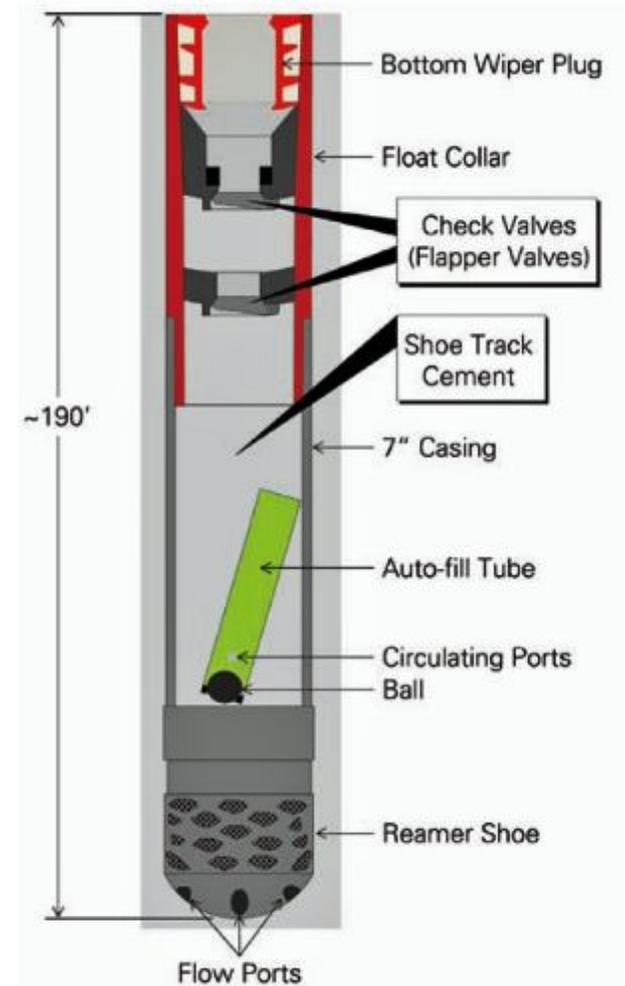
The investigation team identified the following possible failure modes that may have contributed to the shoe track cement's failure to prevent hydrocarbon ingress:

- Contamination of the shoe track cement by nitrogen breakout from the nitrified foam cement.
- Contamination of the shoe track cement by the mud in the wellbore.
- Inadequate design of the shoe track cement.
- Swapping of the shoe track cement with the mud in the rat hole (bottom of the hole).
- A combination of these factors.

Figure 2. Shoe Track Barriers.

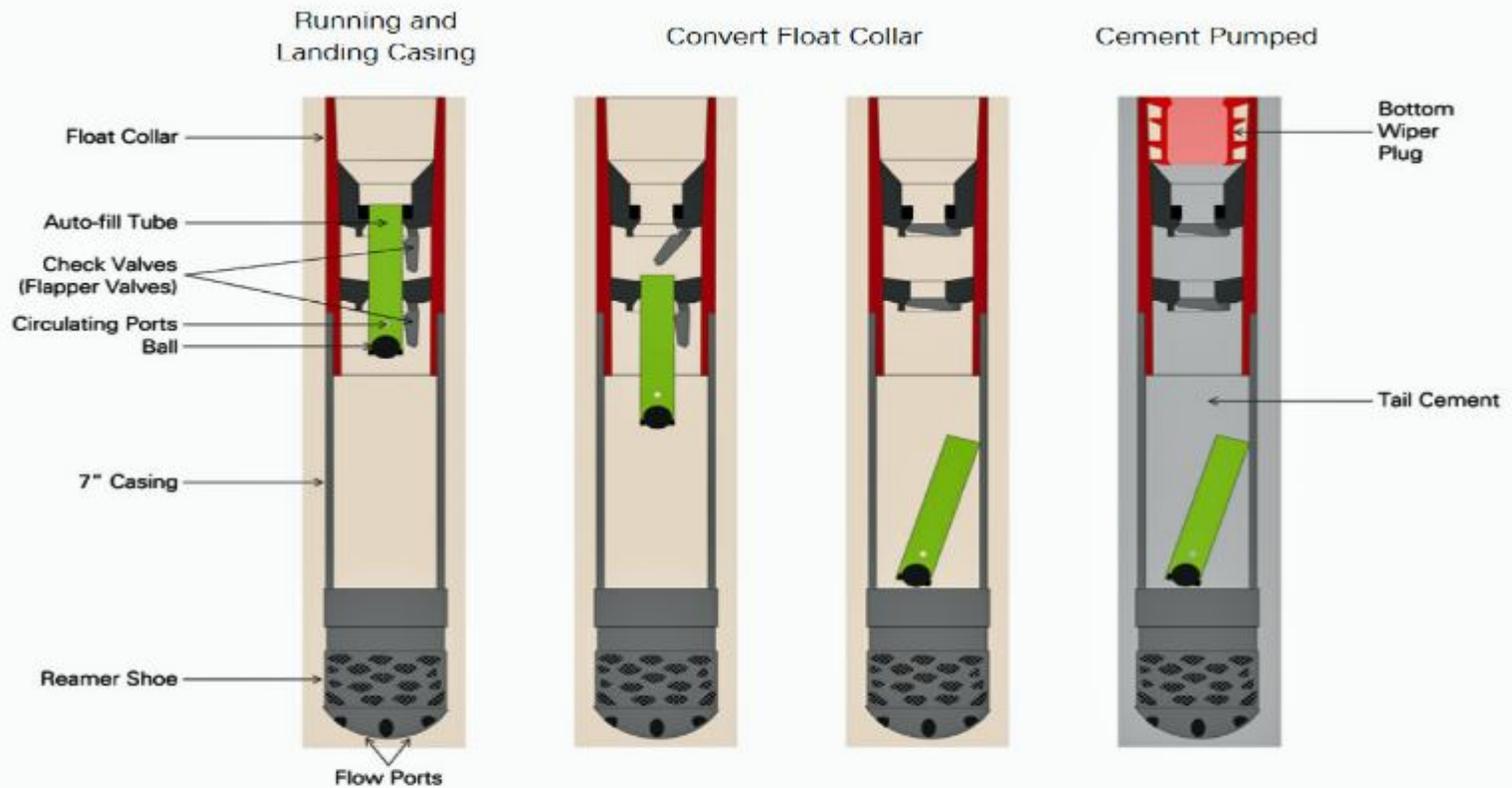
Figure 5. Float Collar Conversion.

Three possible failure modes for the float collar were identified:

- It was damaged by the high load conditions required to establish circulation.
- It failed to convert due to insufficient flow rate.
- The check valves failed to seal.

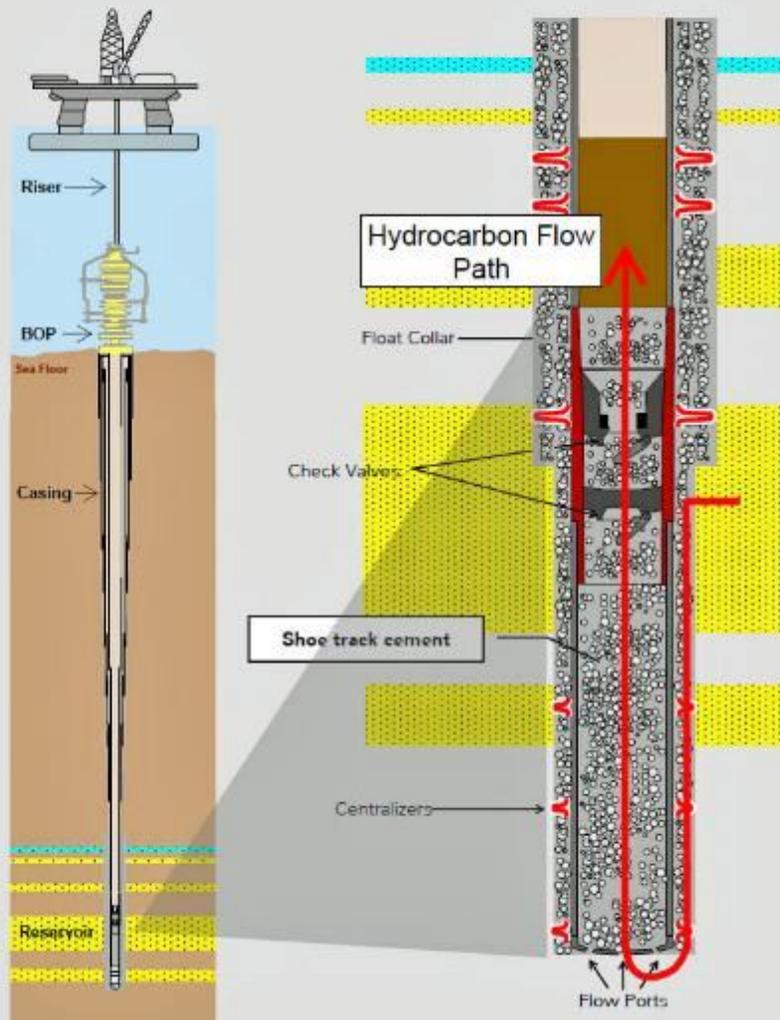
The shoe track mechanical barriers did not isolate the hydrocarbons

Tail cement is displaced down the casing into the shoe track. The tail cement is designed to prevent flow from the annulus into the casing. The float collar valves, which provide a second barrier, must close and seal to prevent flow up the casing.

- Shoe track had two types of mechanical barriers: cement in the shoe track and the double check valves in the float collar
- Shoe track cement failed to act as a barrier due to contamination of the base slurry by break out of nitrogen from the foam slurry
- Hydrocarbon influx was able to bypass the float collar check valves due to either:
 - Valves failed to convert or
 - Valves failed to seal
- Flow through shoe confirmed by fluid modeling and Macondo static kill data

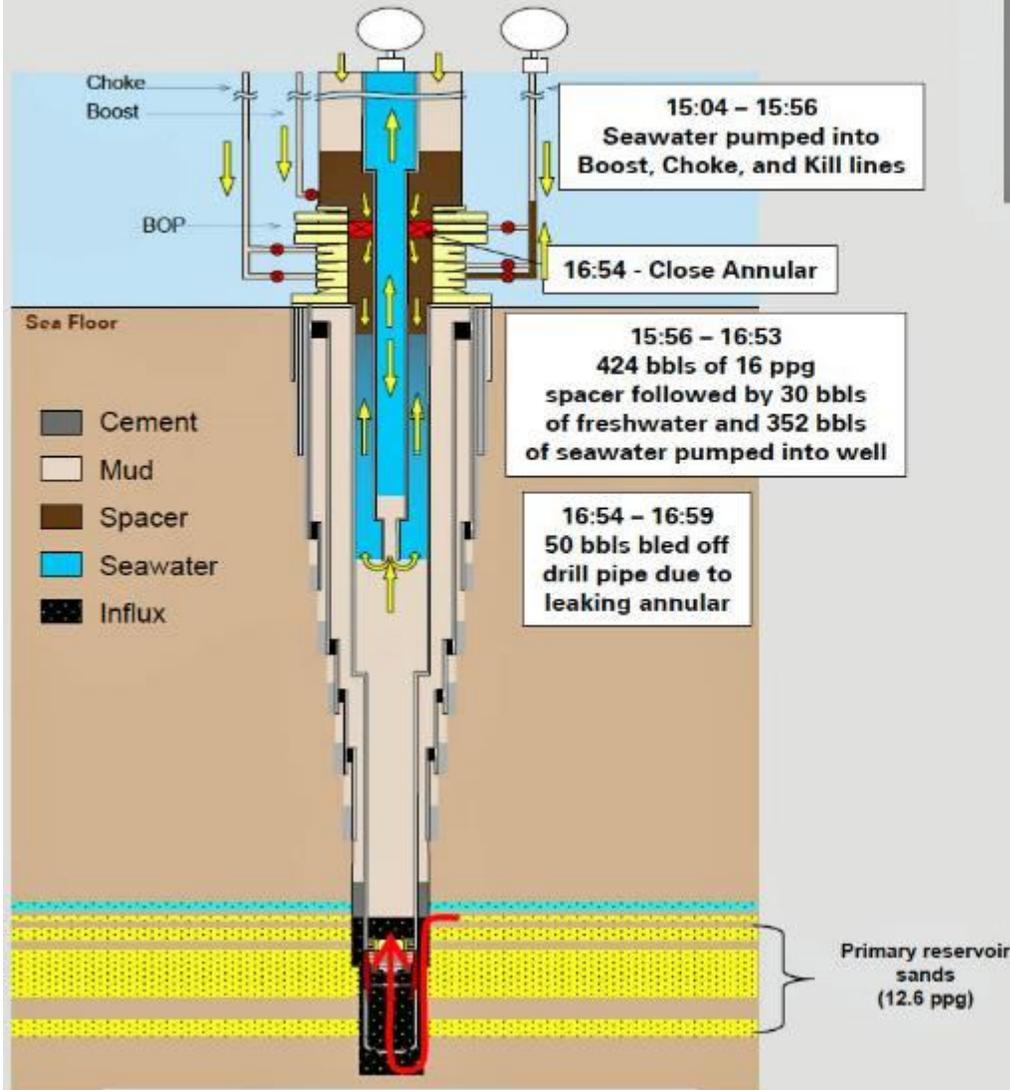
The negative-pressure test checks the integrity of the shoe track, casing and wellhead seal assembly. This simulates conditions during temporary abandonment when a portion of the well is displaced to seawater.

- Negative test simulates underbalanced condition
- Spacer used between mud and seawater
- Leaking annular at start of test moved spacer across kill line inlet
- Negative test started on drill pipe but changed to kill line
- Bleed volumes higher than calculated
- Drill pipe built pressure to 1400 psi with no flow on the kill line

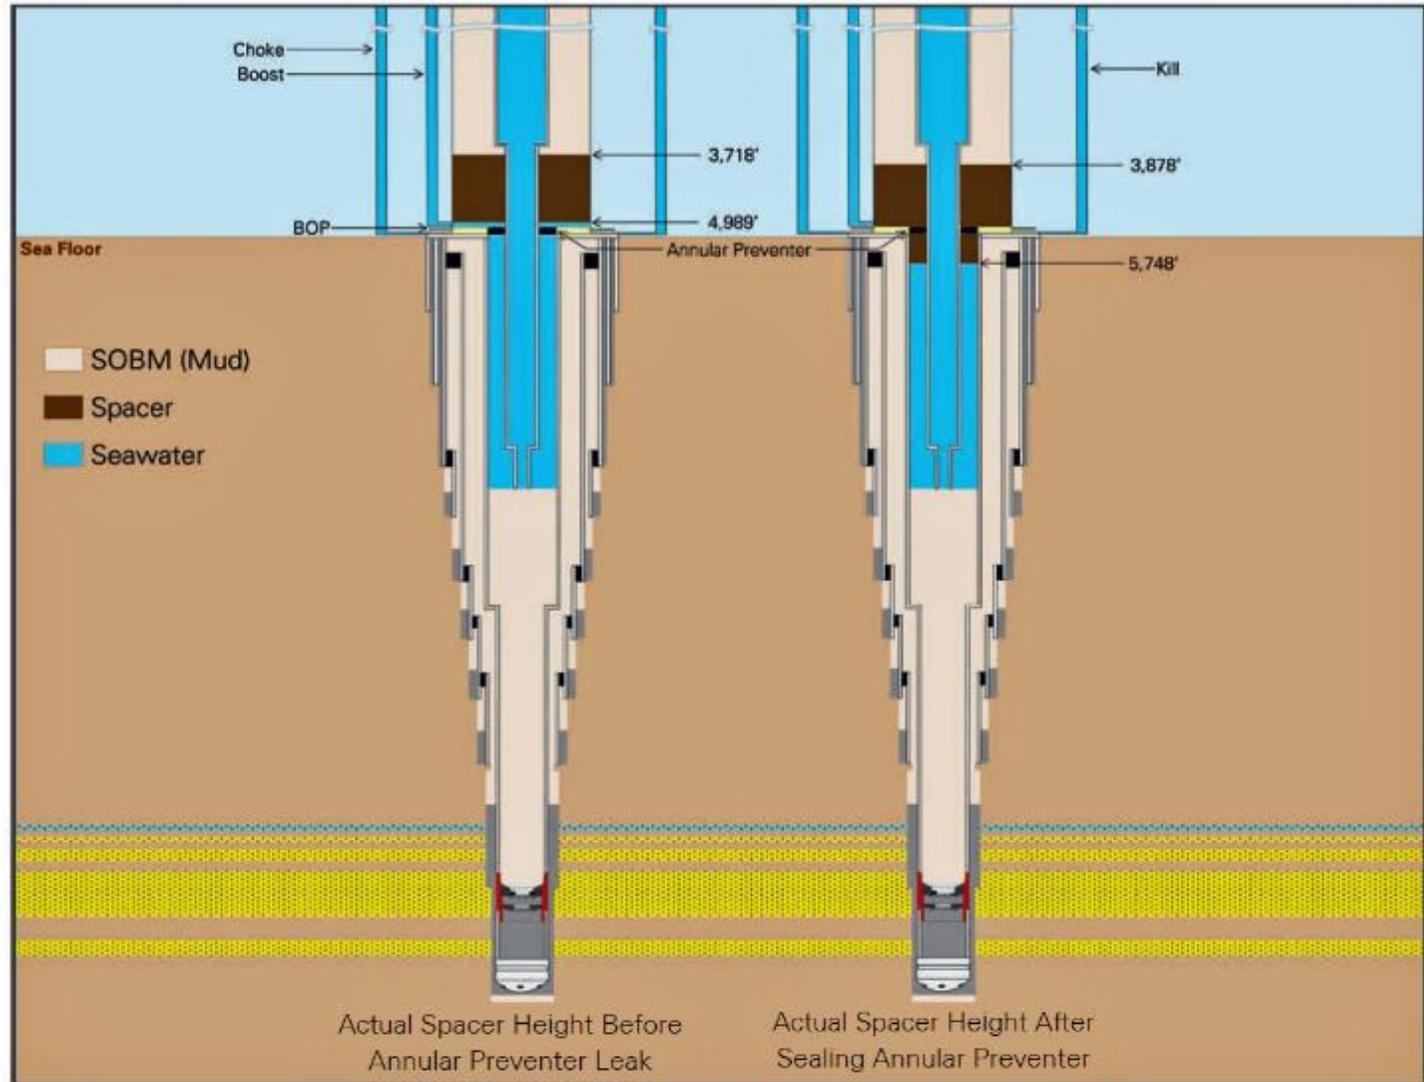
Prueba de presión negativa- Preventor anular no selló

Figure 2. Spacer Placement.

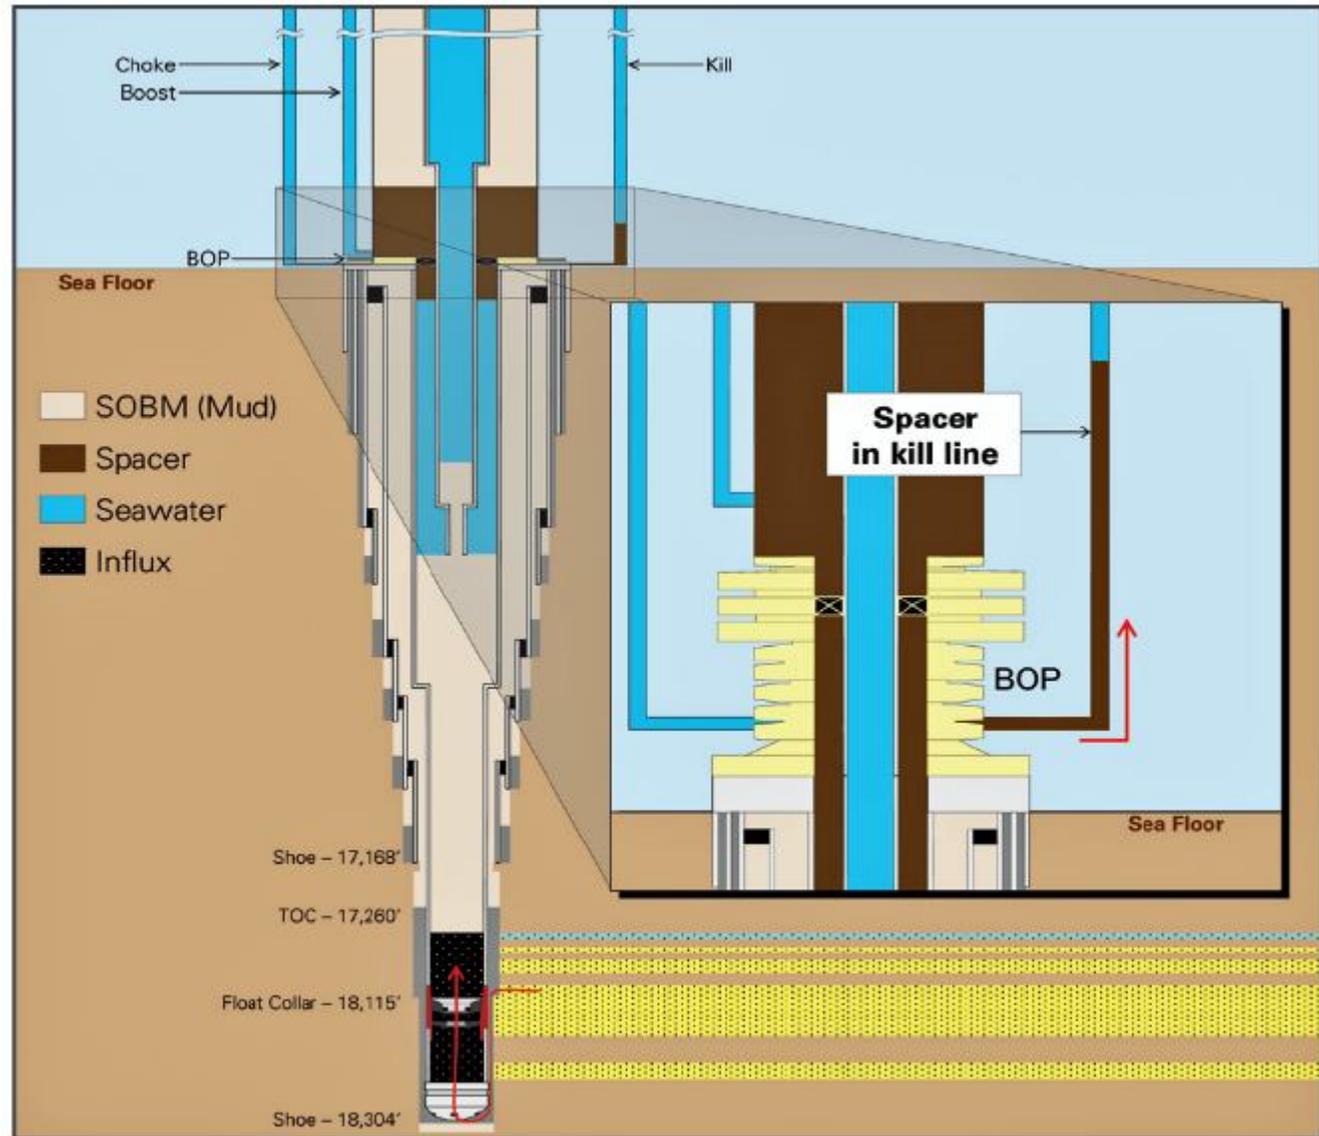
Prueba de presión negativa- Fluido espaciador en el Kill Line

Figure 3. Possible Movement of Spacer into the Kill Line.

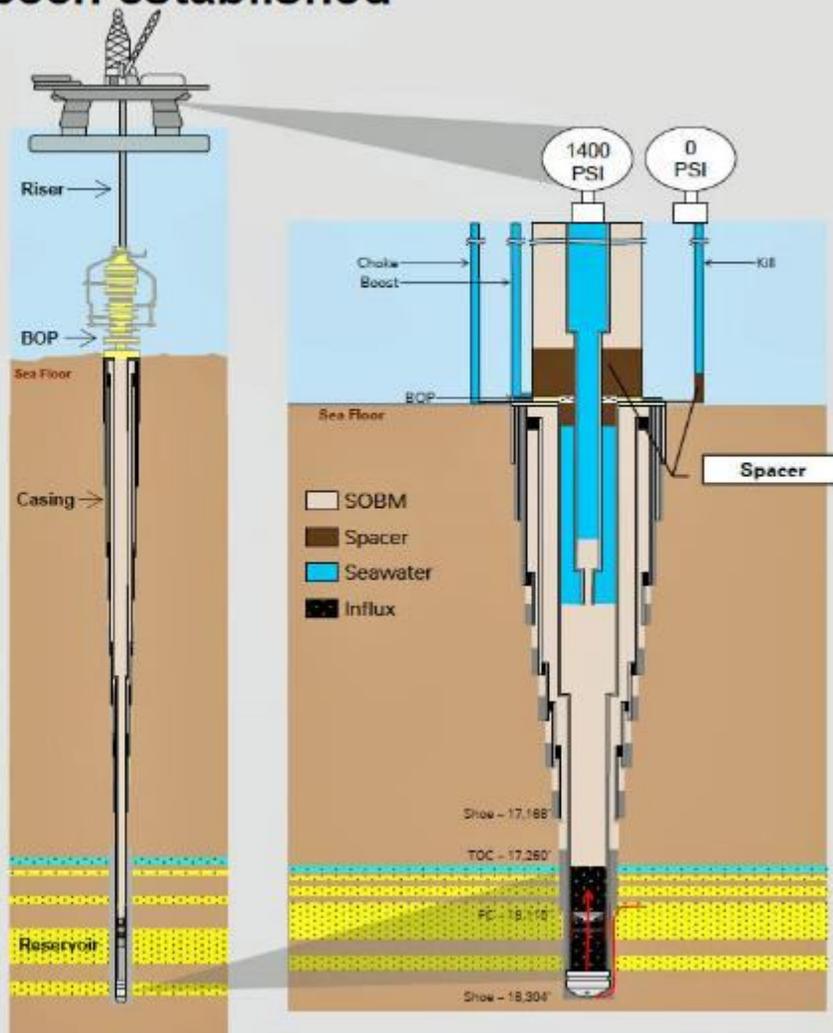
The negative pressure test was accepted although well integrity had not been established

- Bleed volumes not recognized as a problem
- Anomalous pressure on drill pipe with no flow from kill line
- Test incorrectly accepted as successful
- Negative testing not standardized
- Test success/fail criteria not specified

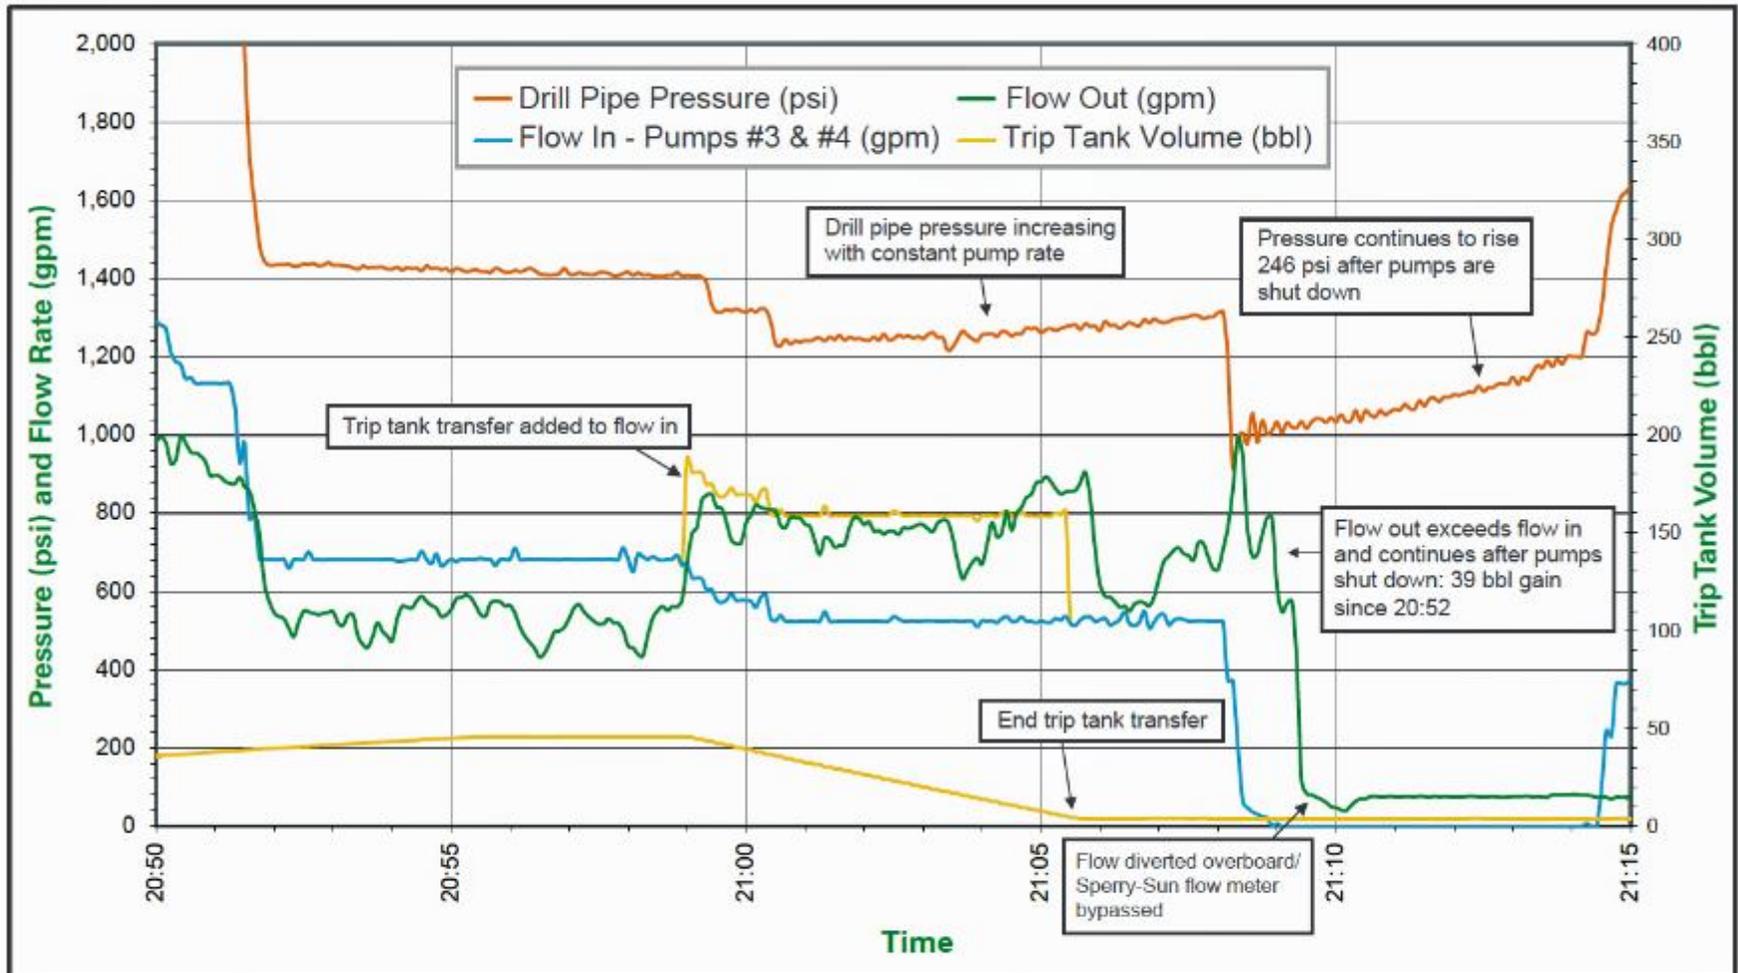
Figure 8. Flow Indication Graph Showing Anomalies (Real-time Data).

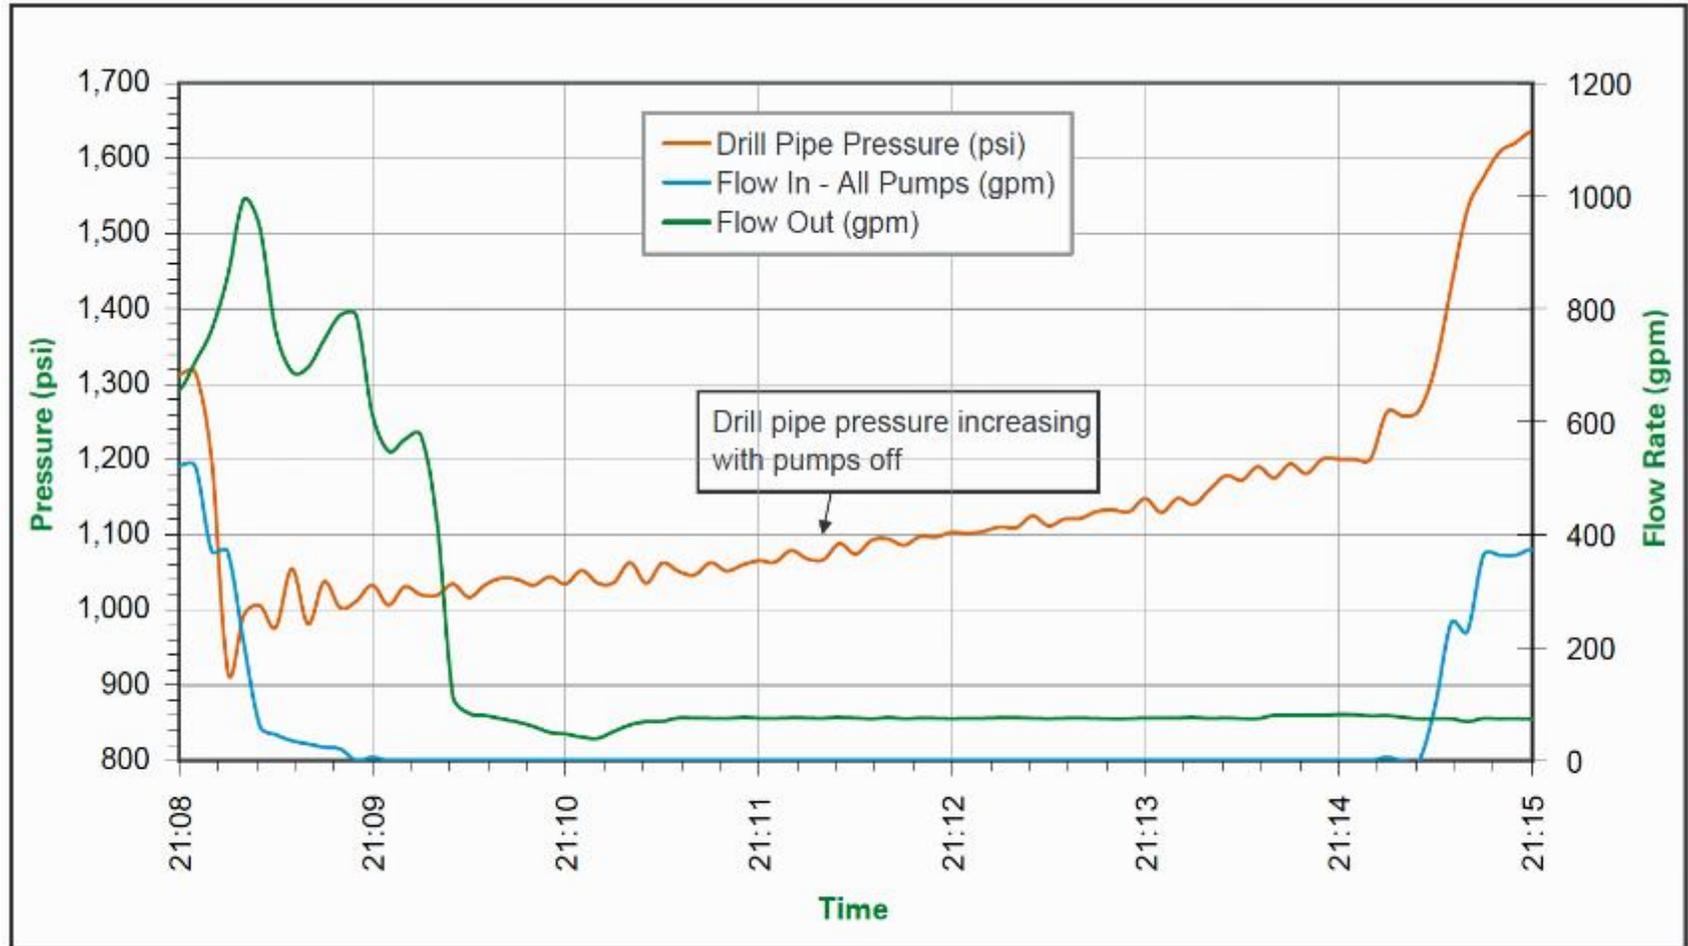
Figure 9. Pressure Increase During the Sheen Test (Real-time Data).

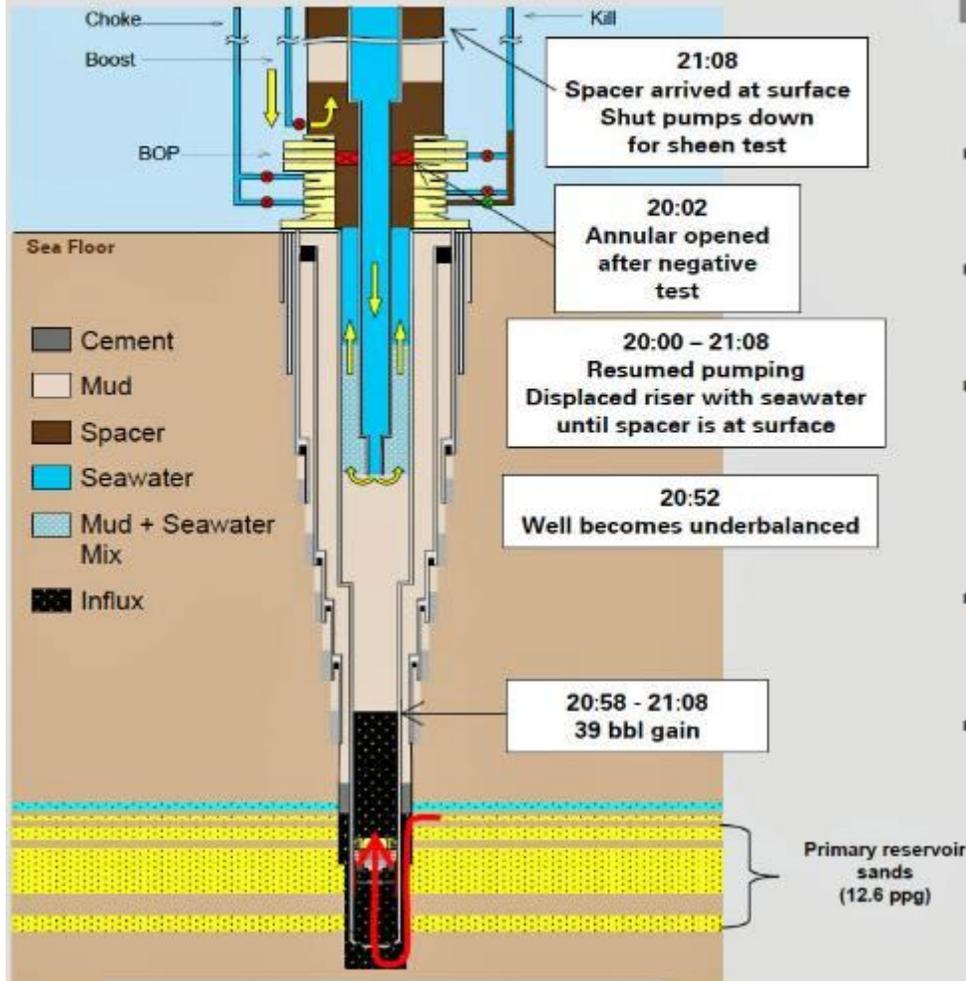
- 20:02 Resume displacement of mud with seawater
- 20:52 Well becomes underbalanced and starts to flow
- After 20:58 gain being taken and pressure begins increasing
 - Flow from well masked by emptying of trip tank
- 21:08 Pumping stops for sheen test
 - Pressure increases with pump off
- 21:14 Sheen test complete, displacement resumes
