Deep Water Horizon Lecciones Aprendidas

Un Reporte de lo ocurrido con la Deepwater
Horizon

En la noche del 20 de abril del 2011, un evento de Well Control permitió que los hidrocarburos salieran del pozo Macondo sobre el semisumergible Deepwater Horizon de la empresa Transocean, resultando en explosiones y fuego en el equipo. 11 personas perdieron la vida, y otras 17 resultaron heridas. El fuego, que fue alimentado por los hidrocarburos que salieron del pozo continuó por 36 horas hasta que el equipo se hundió. Los hidrocarburos continuaron saliendo por el BOP por 87 días, causando un derrame de significancia mundial.

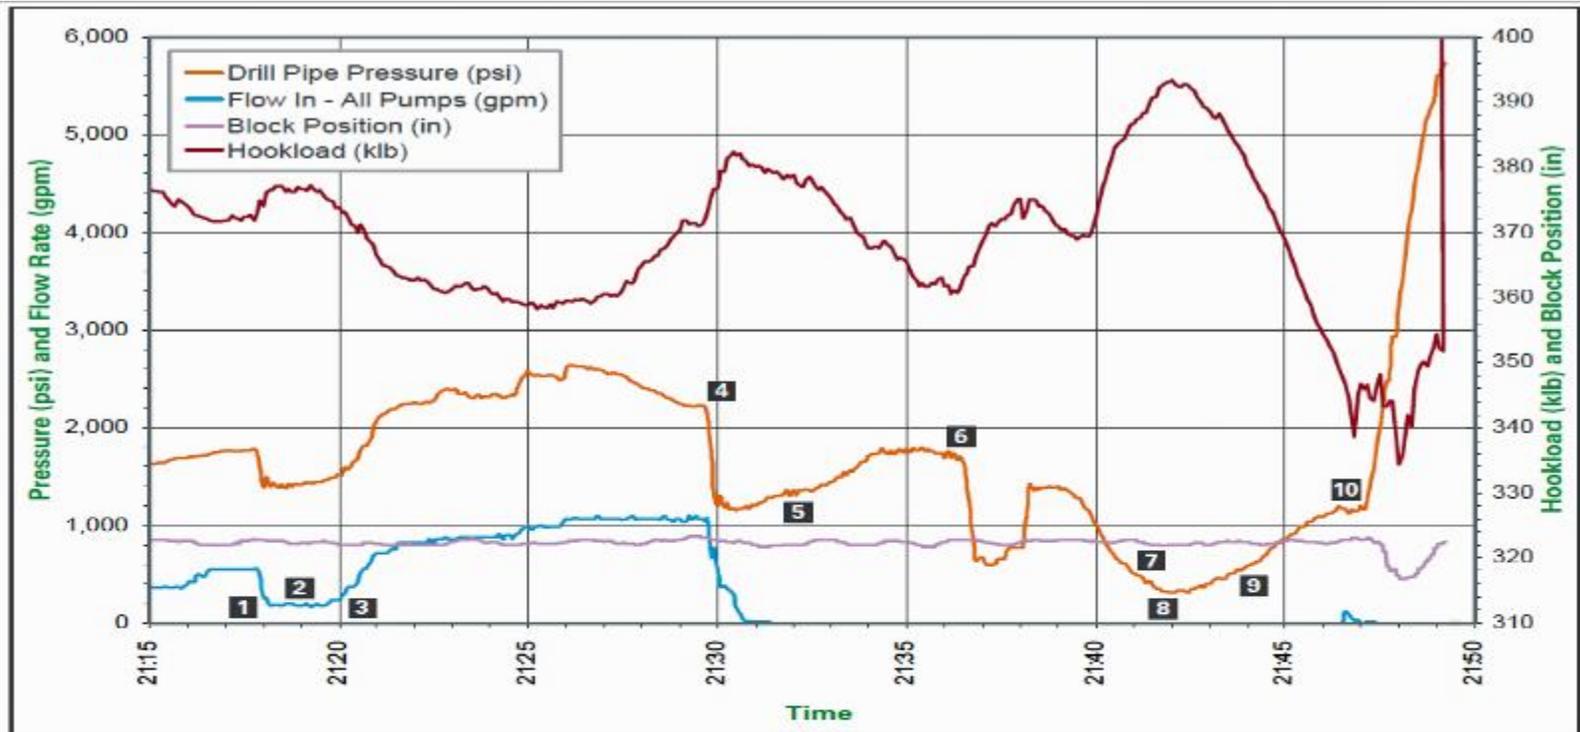
| <ul style="list-style-type: none"> 1 Pressure relief valve on pump #2 opens; toolpusher called to rig floor. 2 All pumps shut down except boost pump. 3 Assistant driller called to pump room. 4 Pumps shut off. 5 Toolpusher and driller discuss 'differential pressure.' 6 Opening of 4" surface line to bleed pressure. | <ul style="list-style-type: none"> 7 Mud/water flows onto rig floor and then unloads through the derrick. 8 Diverter and annular preventer activated; diverted to mud gas separator. 9 Well site leader and senior toolpusher receive calls from rig floor; annular preventer attempting to close. 10 BOP sealing. |

Figure 17. Interpretation of Well Control Response (Real-time Data).

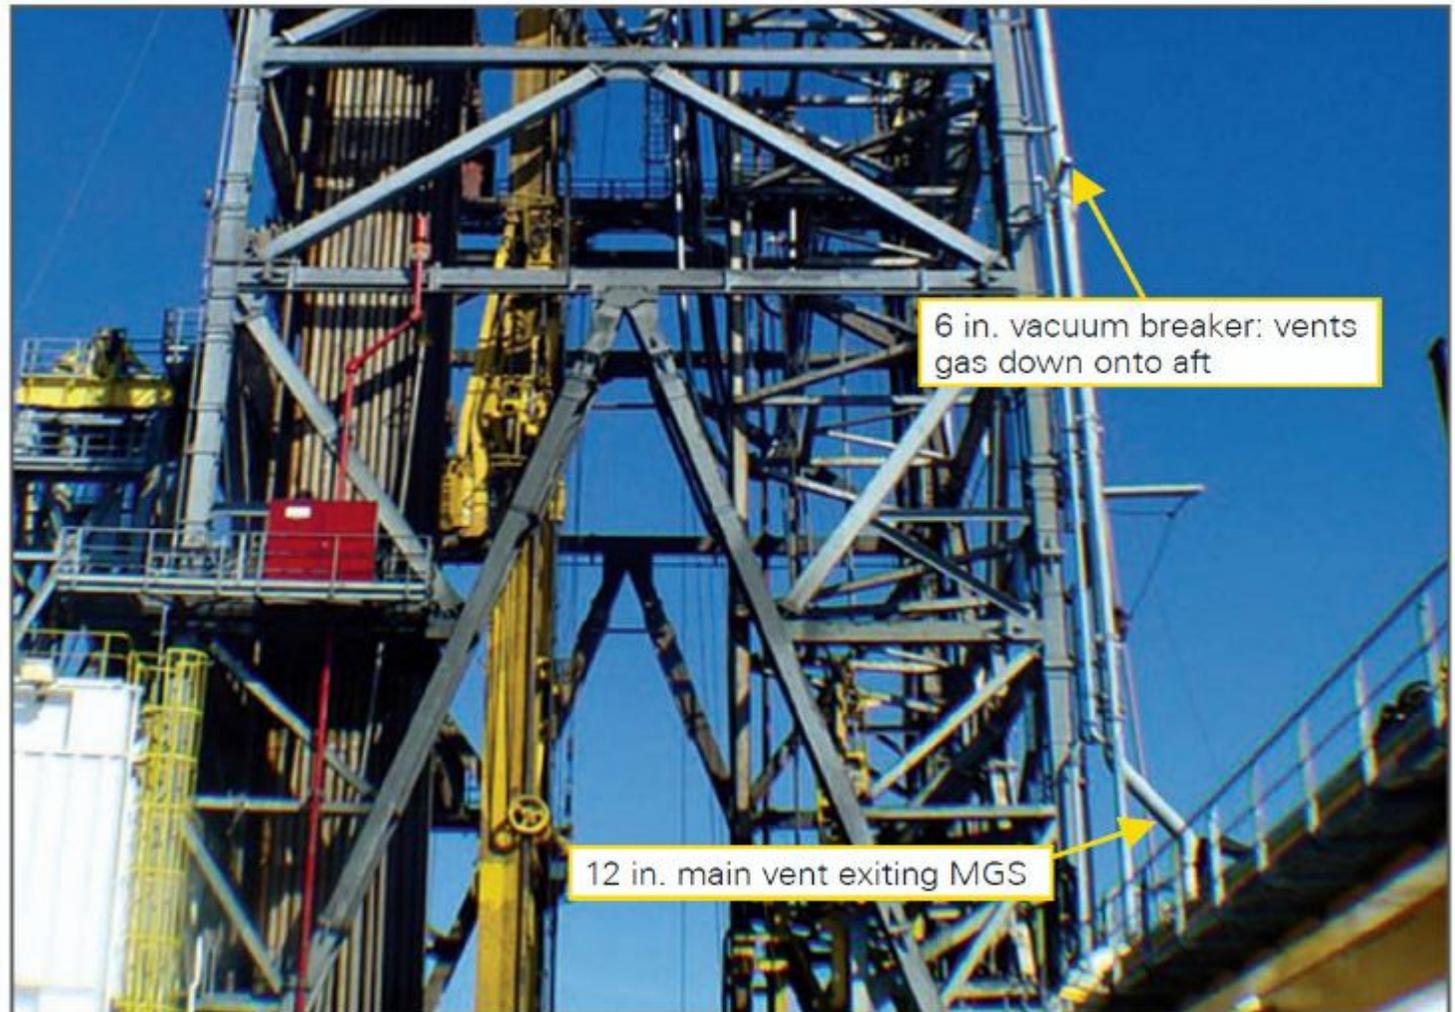
Figure 5. Photograph of 6 in. Vacuum Breaker Line Gooseneck Vent.

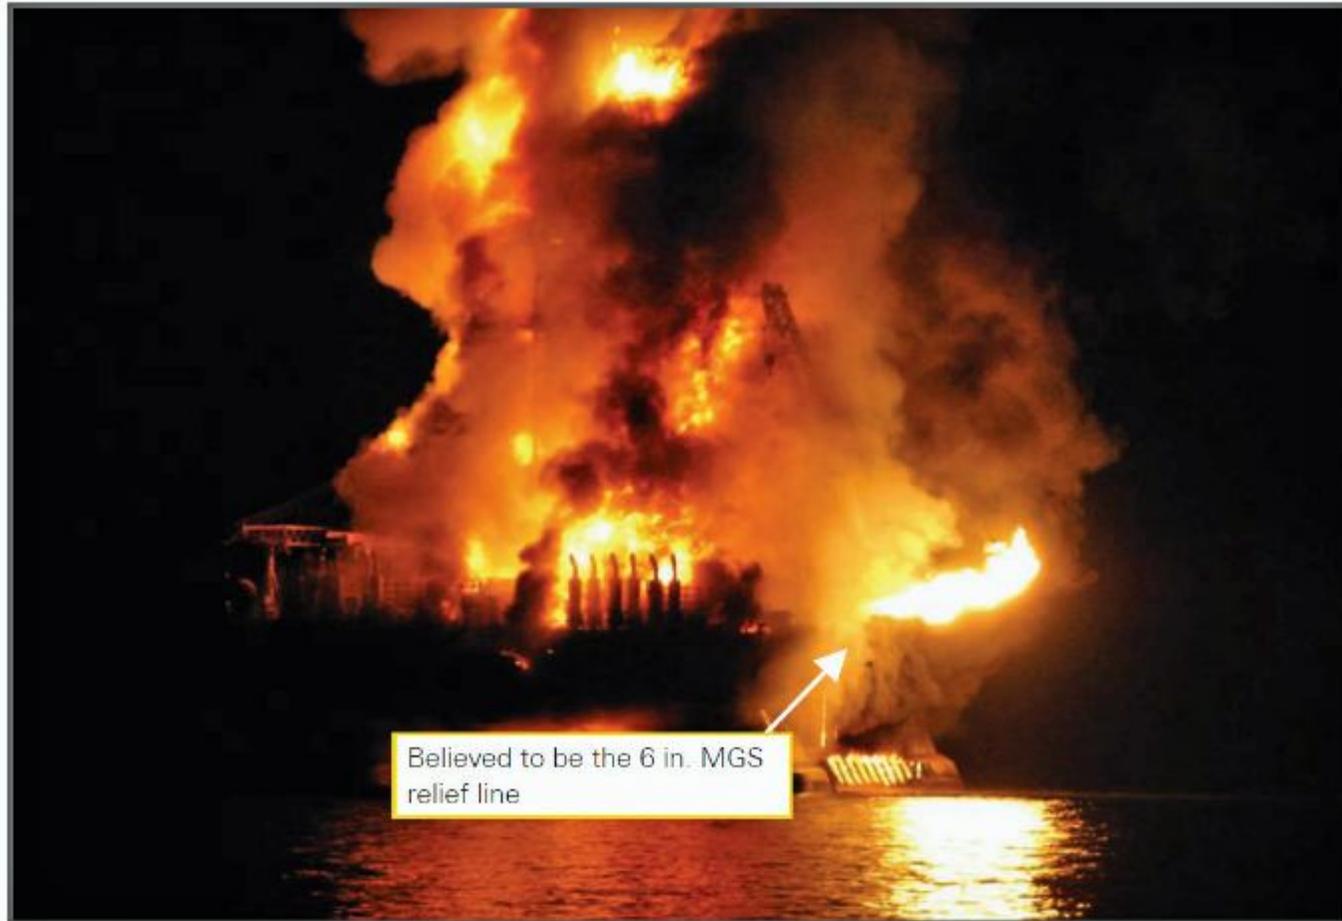
Figure 7. *Deepwater Horizon* Photograph Showing a Starboard Jet Flame.

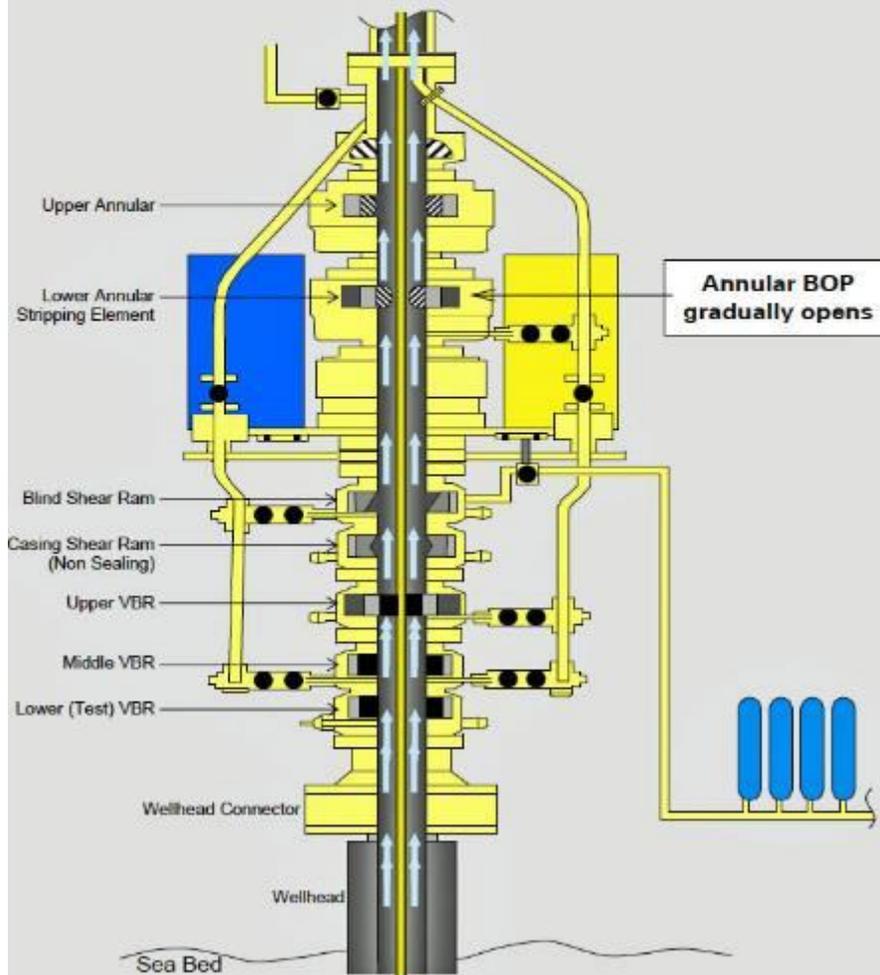
- Damage to MUX cables and hydraulic line
 - Opening of annular BOP
- Rig drifted off location
 - Upward movement of the drill pipe in the BOP

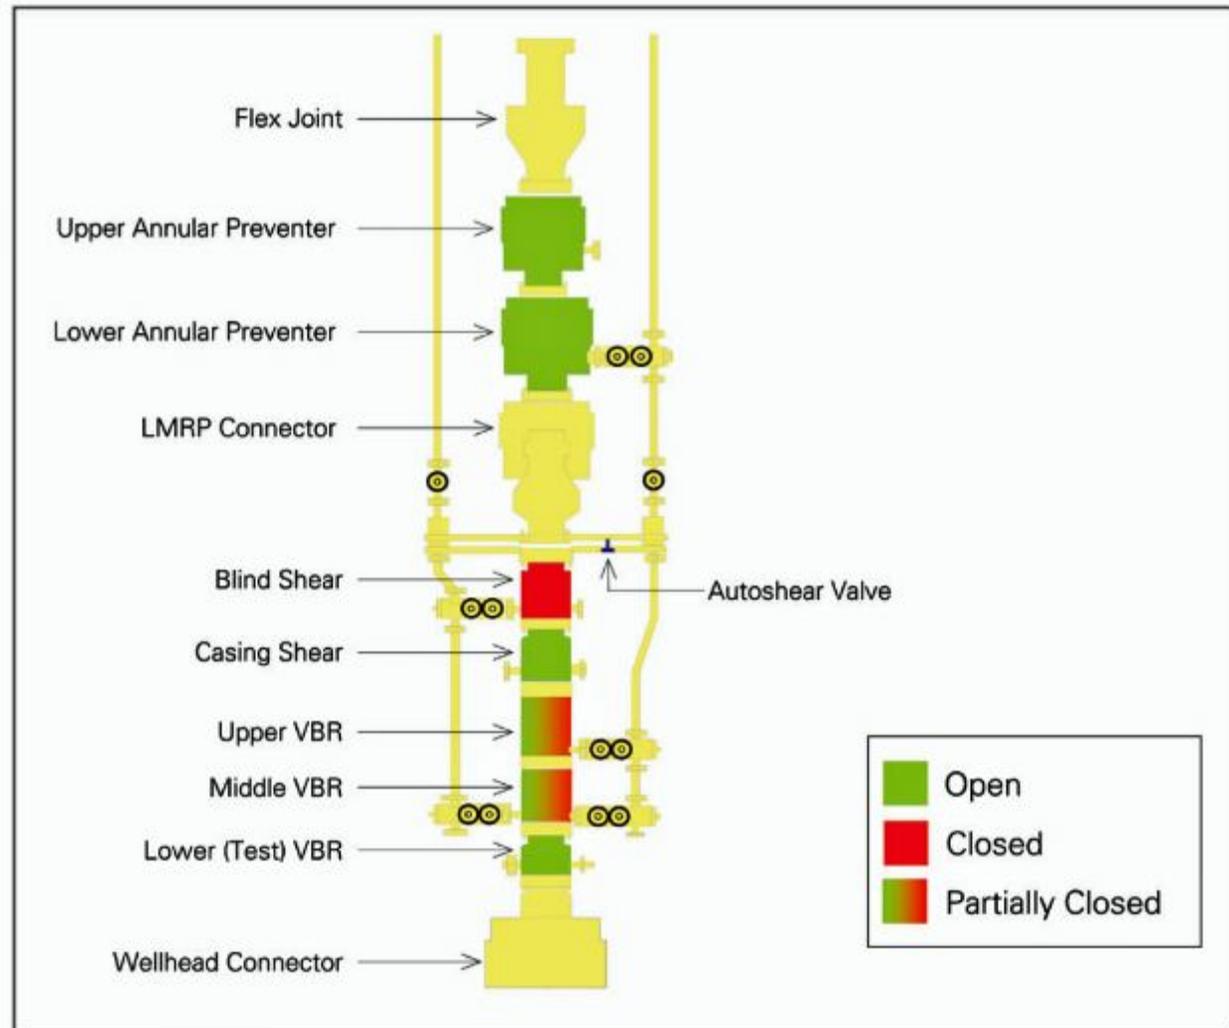
Figure 13. Likely Status of BOP Rams Immediately After Autoshear Initiation.

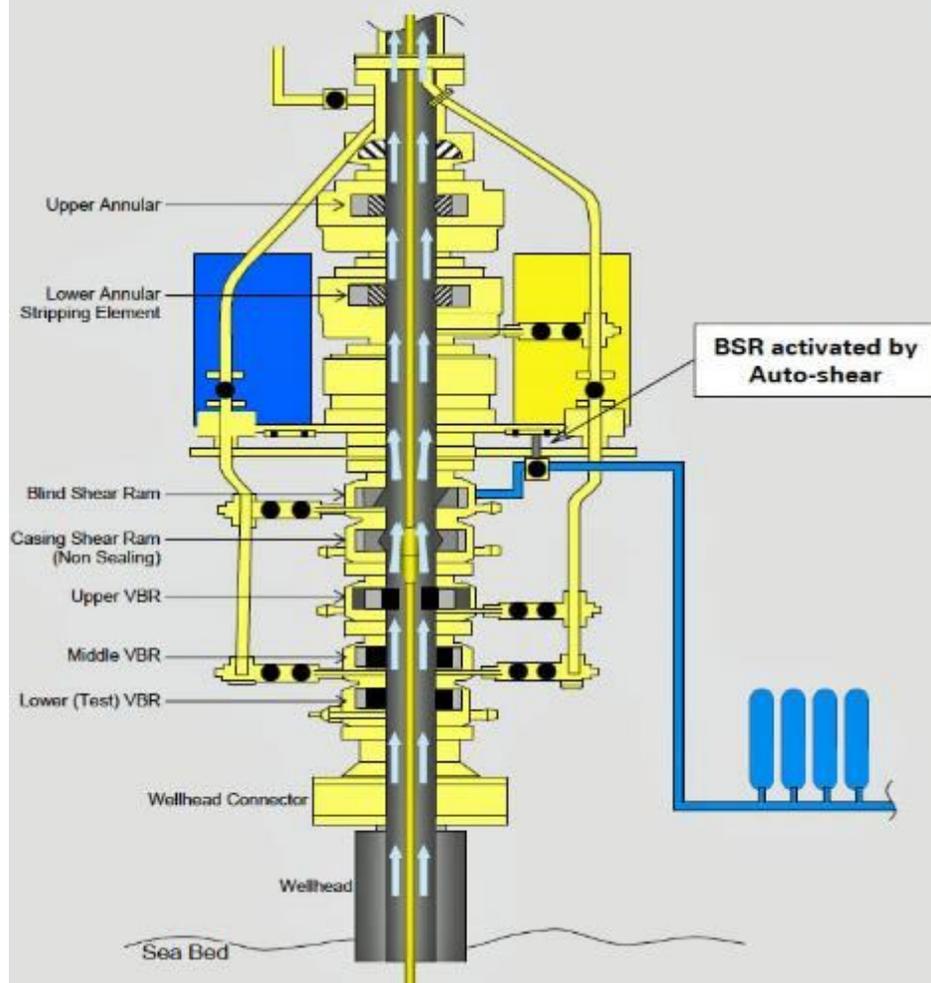
- EDS attempts failed to activate BSR
- AMF sequence likely failed to activate BSR

- ROV hot stab attempts to close BOP were ineffective
- ROV simulated AMF function likely failed to activate BSR
- ROV activated auto-shear appears to have activated but did not seal the well

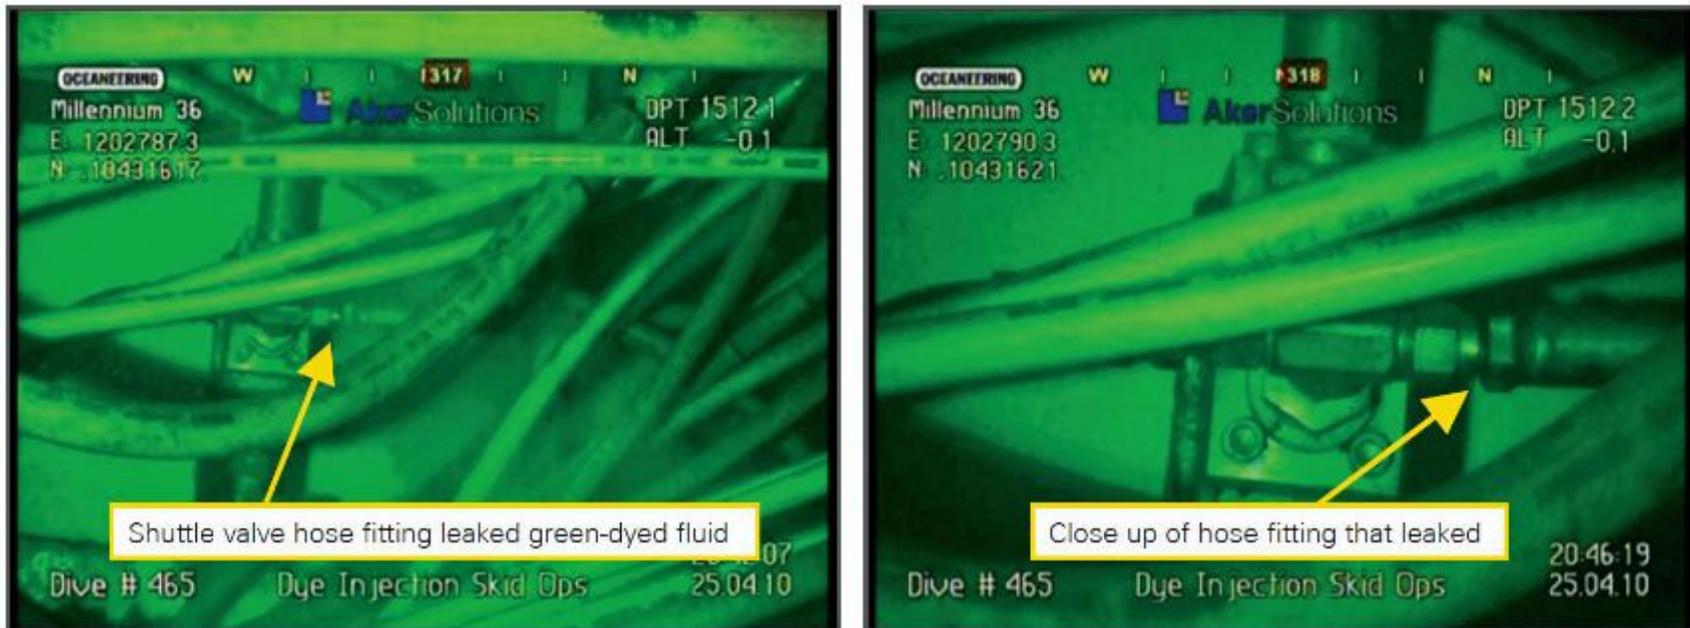
Figure 18. ROV Video Stills of Leaking Hose Fitting on a Shuttle Valve in the ST Lock Hydraulic Circuit. (Green-dyed water around this location indicates the severity of the leak.)

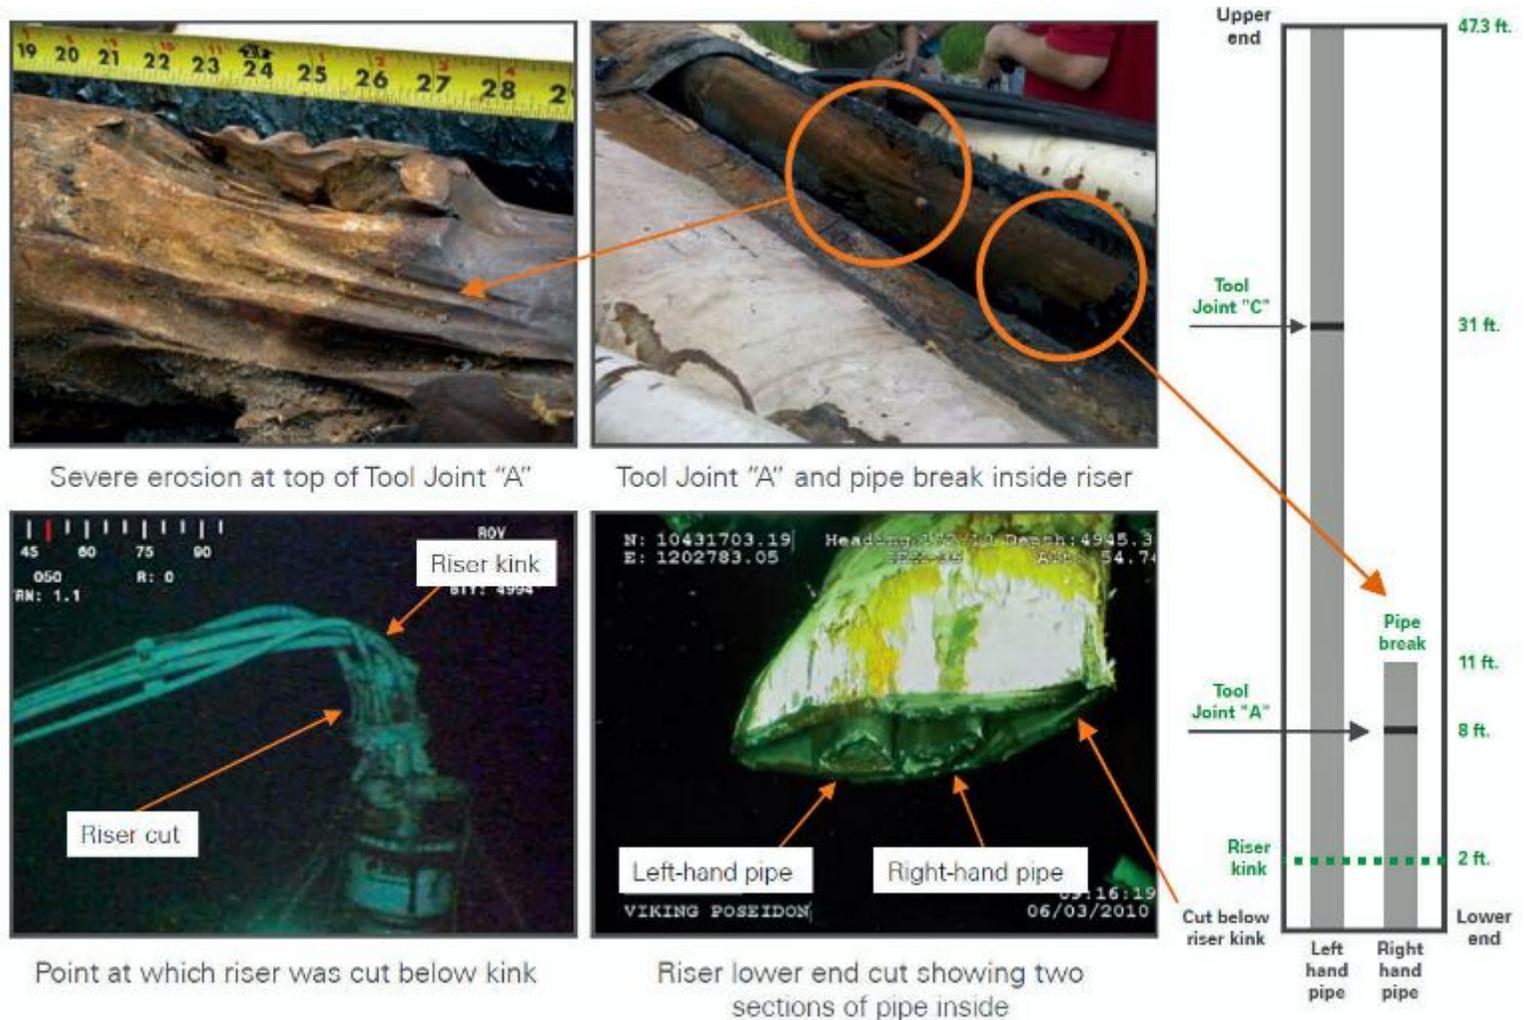
Figure 14. Retrieved Riser Kink Section and Its Contents.

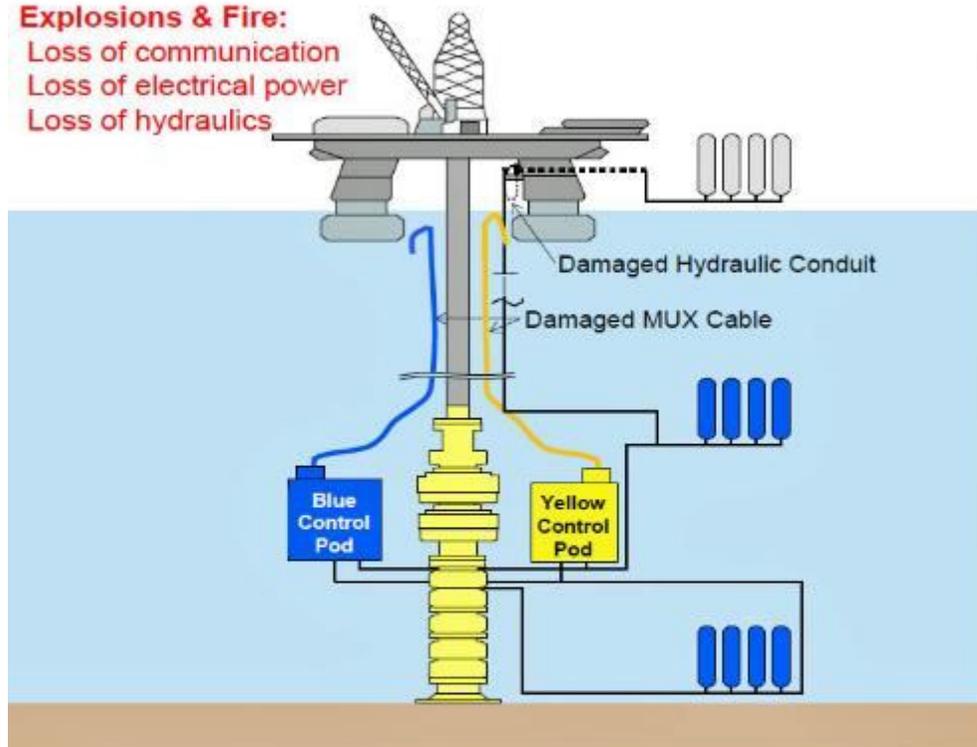
- EDS function was inoperable due to damage to MUX cables
- AMF could not activate the BSR due to defects in both control pods
- Auto-shear appears to have activated the BSR but did not seal the well
- Potential weaknesses found in the BOP testing regime and maintenance management systems
