Deep Water Horizon Lecciones Aprendidas

Un Reporte de lo ocurrido con la Deepwater
Horizon

En la noche del 20 de abril del 2011, un evento de Well Control permitió que los hidrocarburos salieran del pozo Macondo sobre el semisumergible Deepwater Horizon de la empresa Transocean, resultando en explosiones y fuego en el equipo. 11 personas perdieron la vida, y otras 17 resultaron heridas. El fuego, que fue alimentado por los hidrocarburos que salieron del pozo continuó por 36 horas hasta que el equipo se hundió. Los hidrocarburos continuaron saliendo por el BOP por 87 días, causando un derrame de significancia mundial.

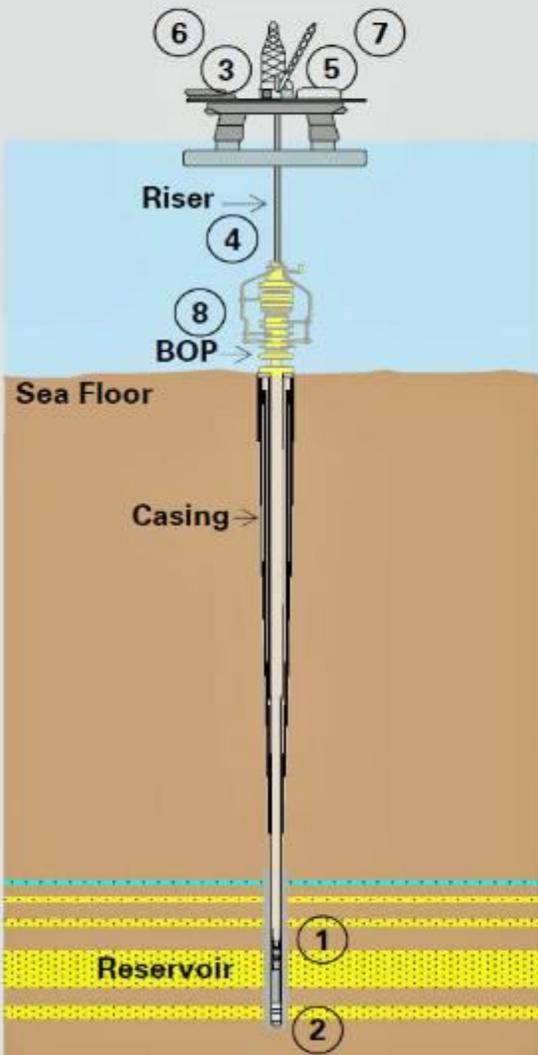
Ocho barreras fueron irrumpidas

- I. **No se estableció la integridad del pozo**
 - 1) La barrera de cemento en el anular no aisló a los HC
 - 2) La barrera del shoe track no aisló los HC
- II. **Los HC que ingresaron al pozo no fueron detectados y se perdió el control del pozo**
 - 3) La prueba de presión negativa fue aceptada aunque la integridad del pozo no se había establecido
 - 4) El influjo no fue reconocido hasta que los HC estuvieron en el Riser
 - 5) Las acciones de respuesta de control de pozos fallaron y no se pudo controlar.
- III. **Los HC se prendieron en la Deepwater Horizon**
 - 6) La línea de venteo del separador de gas iba al equipo
 - 7) No se previno la ignición del gas
- IV. **El BOP stack no selló el pozo**
 - 8) El BOP en modo de emergencia no selló el pozo

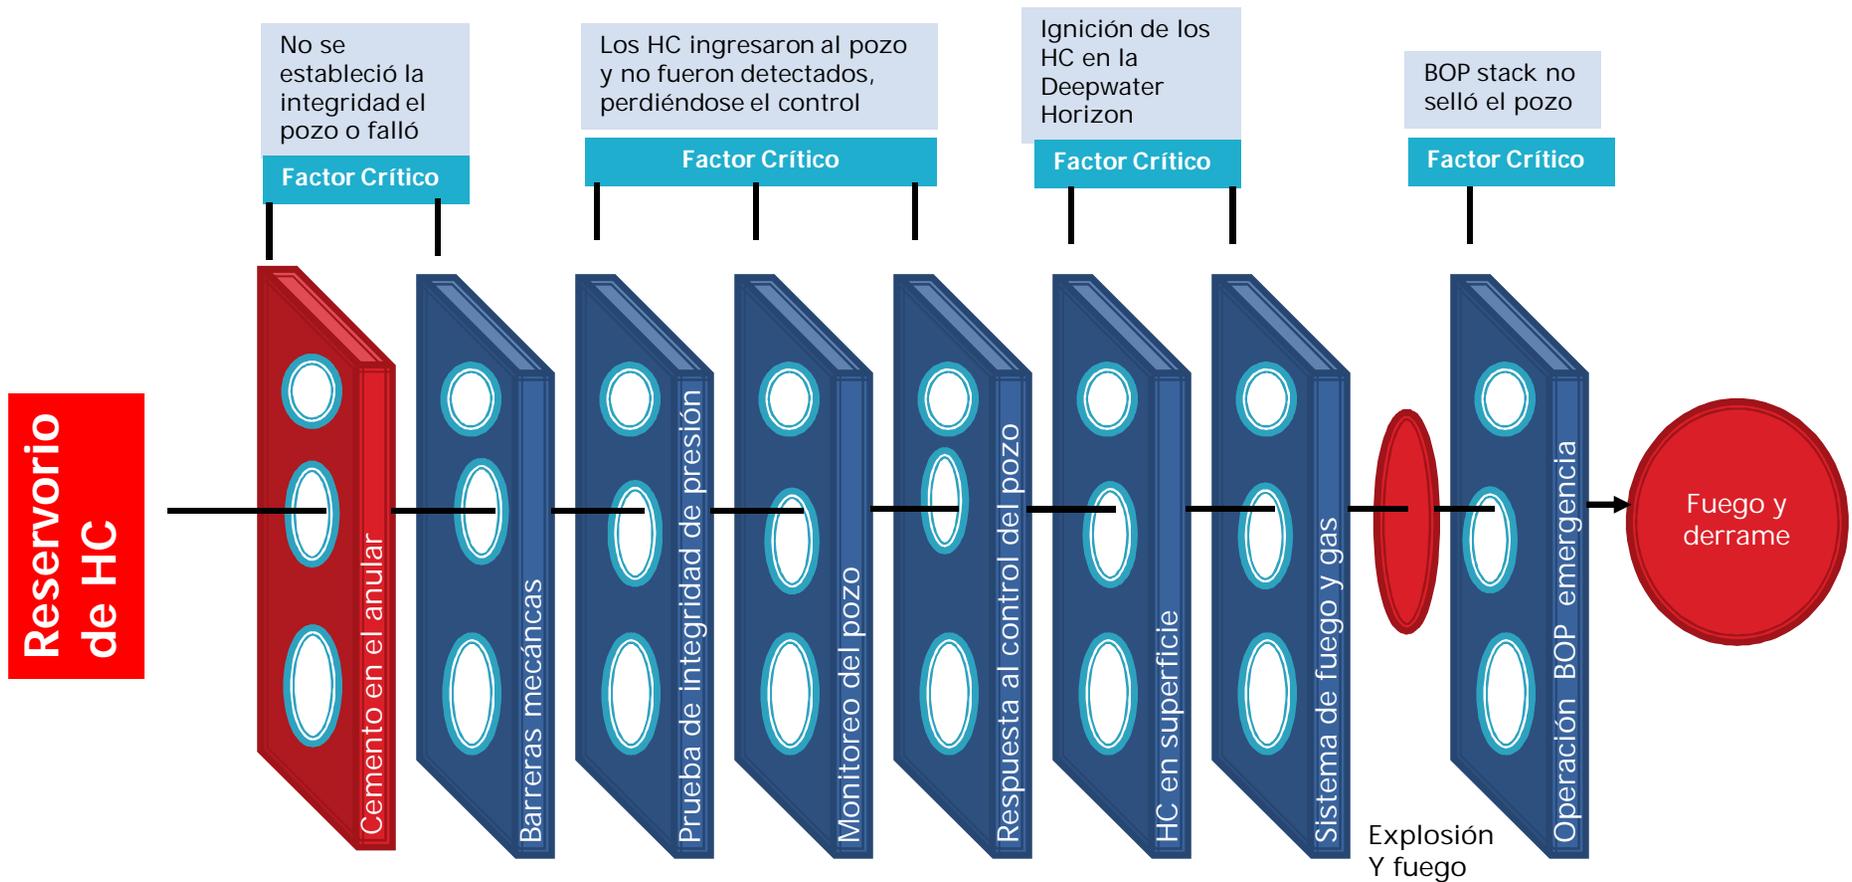
Hallazgo 1. La barrera de cemento en el anular no aisló a los HC

La barrera de cemento anular no pudo evitar que los HC migraran hacia el pozo. El análisis del equipo de investigación identificó una probable explicación técnica de esta falla.

Las interacciones entre BP y Halliburton y las deficiencias en la planificación, diseño, ejecución y confirmación del trabajo de cemento redujeron las perspectivas de un trabajo de cemento exitoso

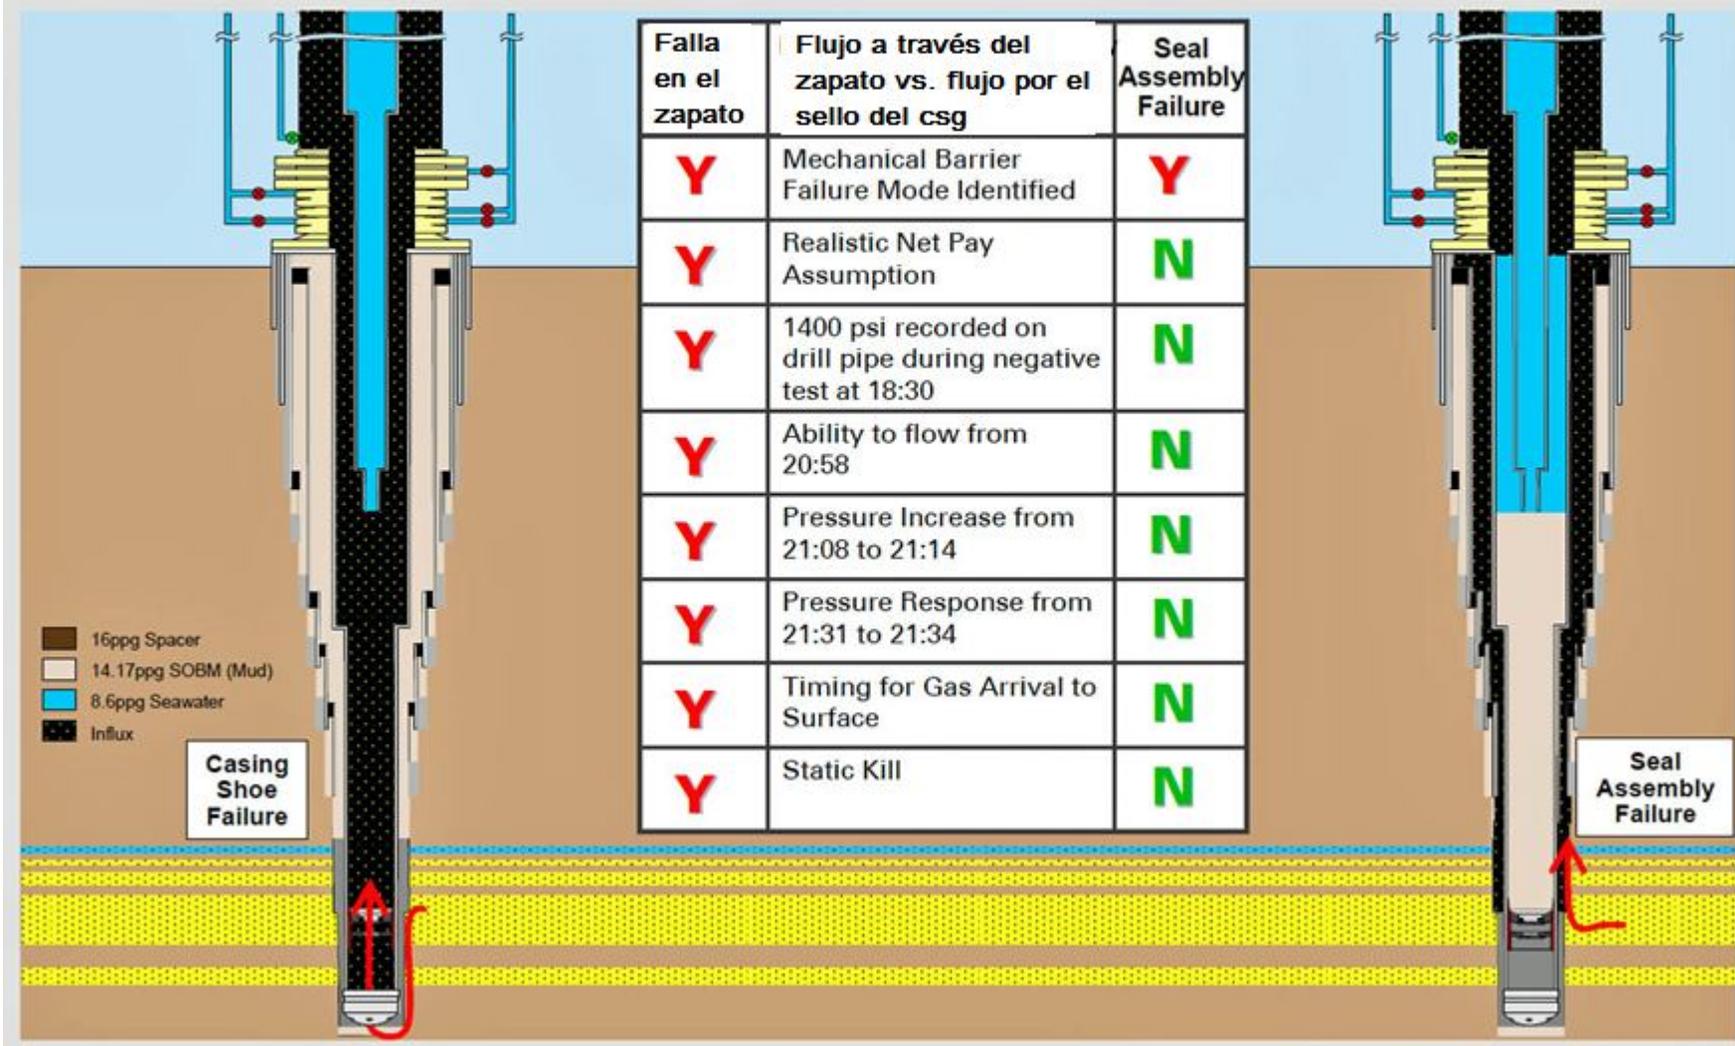
Flujo a través del shoe track - Evidencias de soporte

Por la evidencia disponible y análisis se concluyó que el influjo atravesó la barrera del shoe track

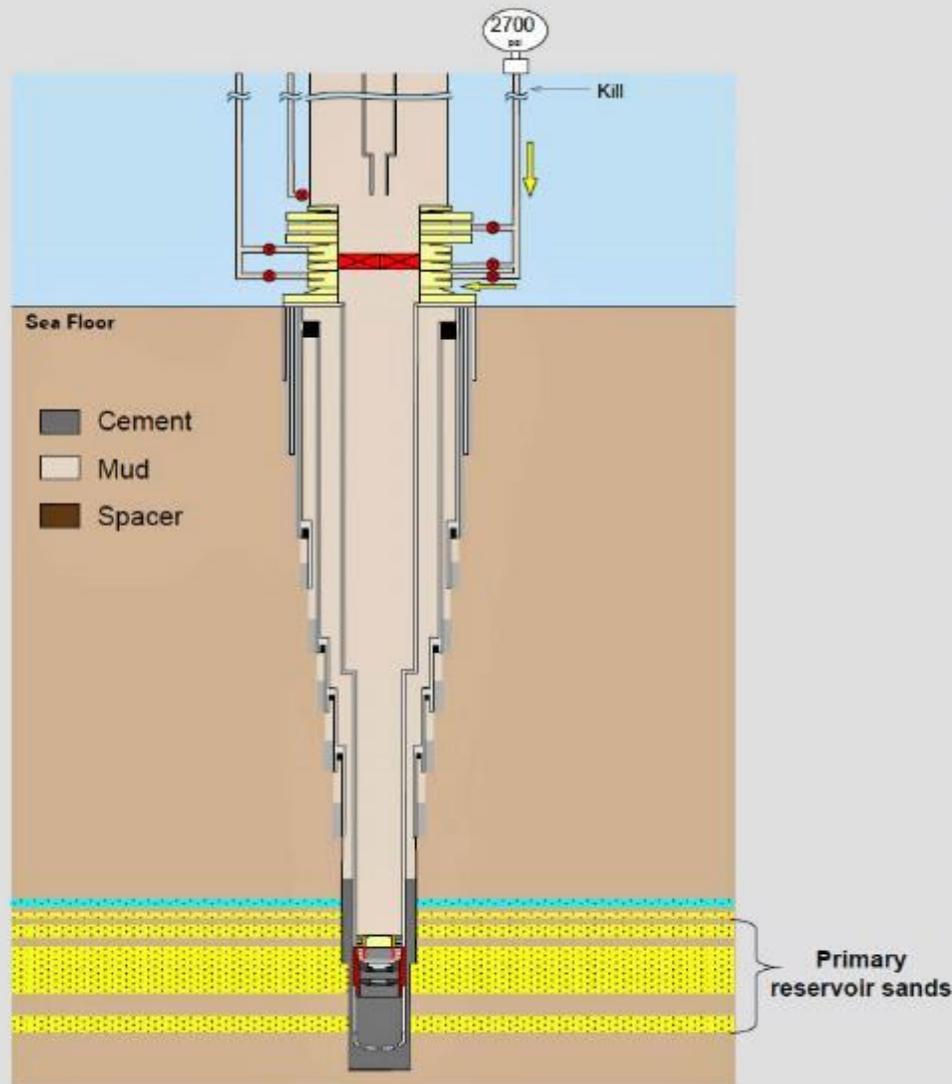
Casing (Positive) Pressure Test

A positive pressure test verifies the integrity of the casing and seal assembly.

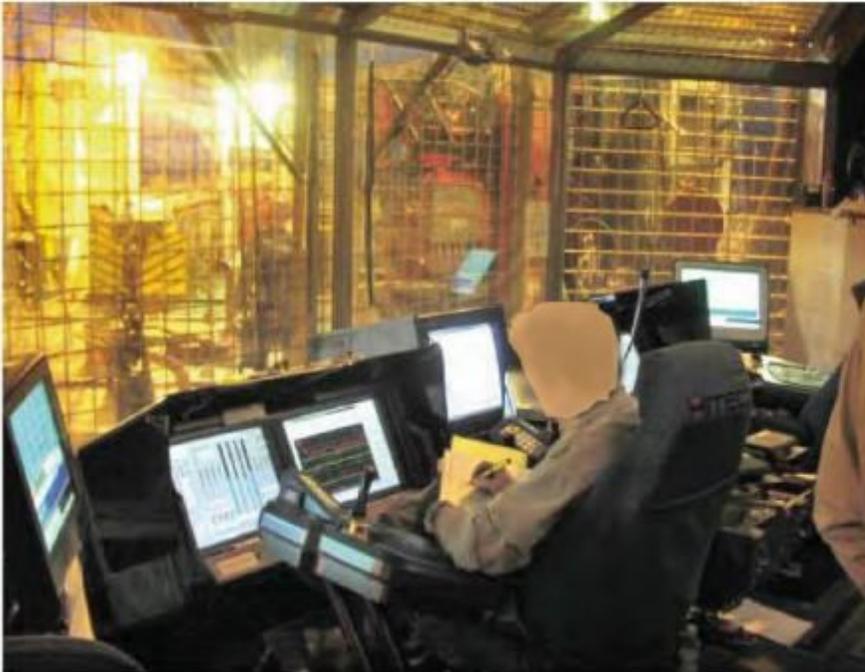
Well Monitoring – Driller's Console and Mudlogging unit

- Well monitoring is performed to understand if the well has losses or gains
- Driller is responsible for monitoring and shutting in the well
- The mudlogger provides monitoring support to the driller
- Displays and trending capability available in both Driller's and Mudlogger's cabins
- Flow, pressure and pit sensors can indicate flow
- Simultaneous activities were taking place on April 20th to prepare for rig move
- Standards for monitoring do not specifically address end-of-well activities

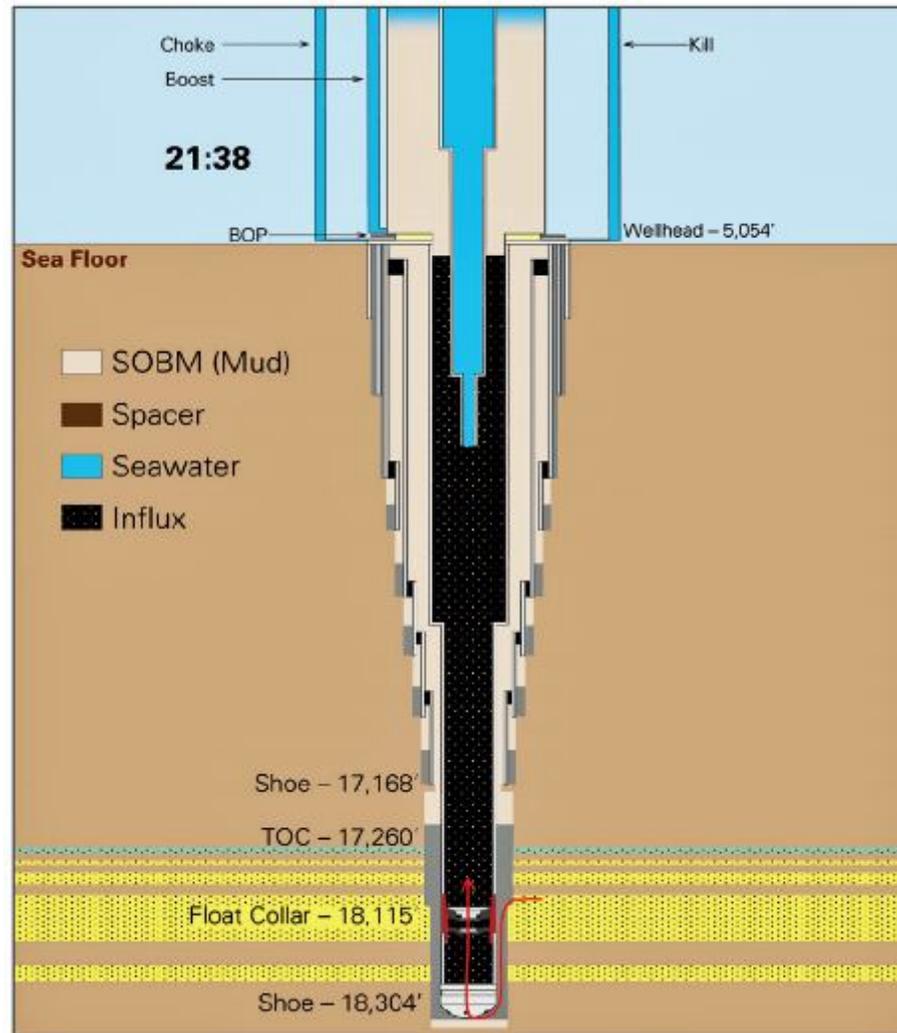
Figure 4. Hydrocarbons Entering the Riser.

No se reconoció el influjo

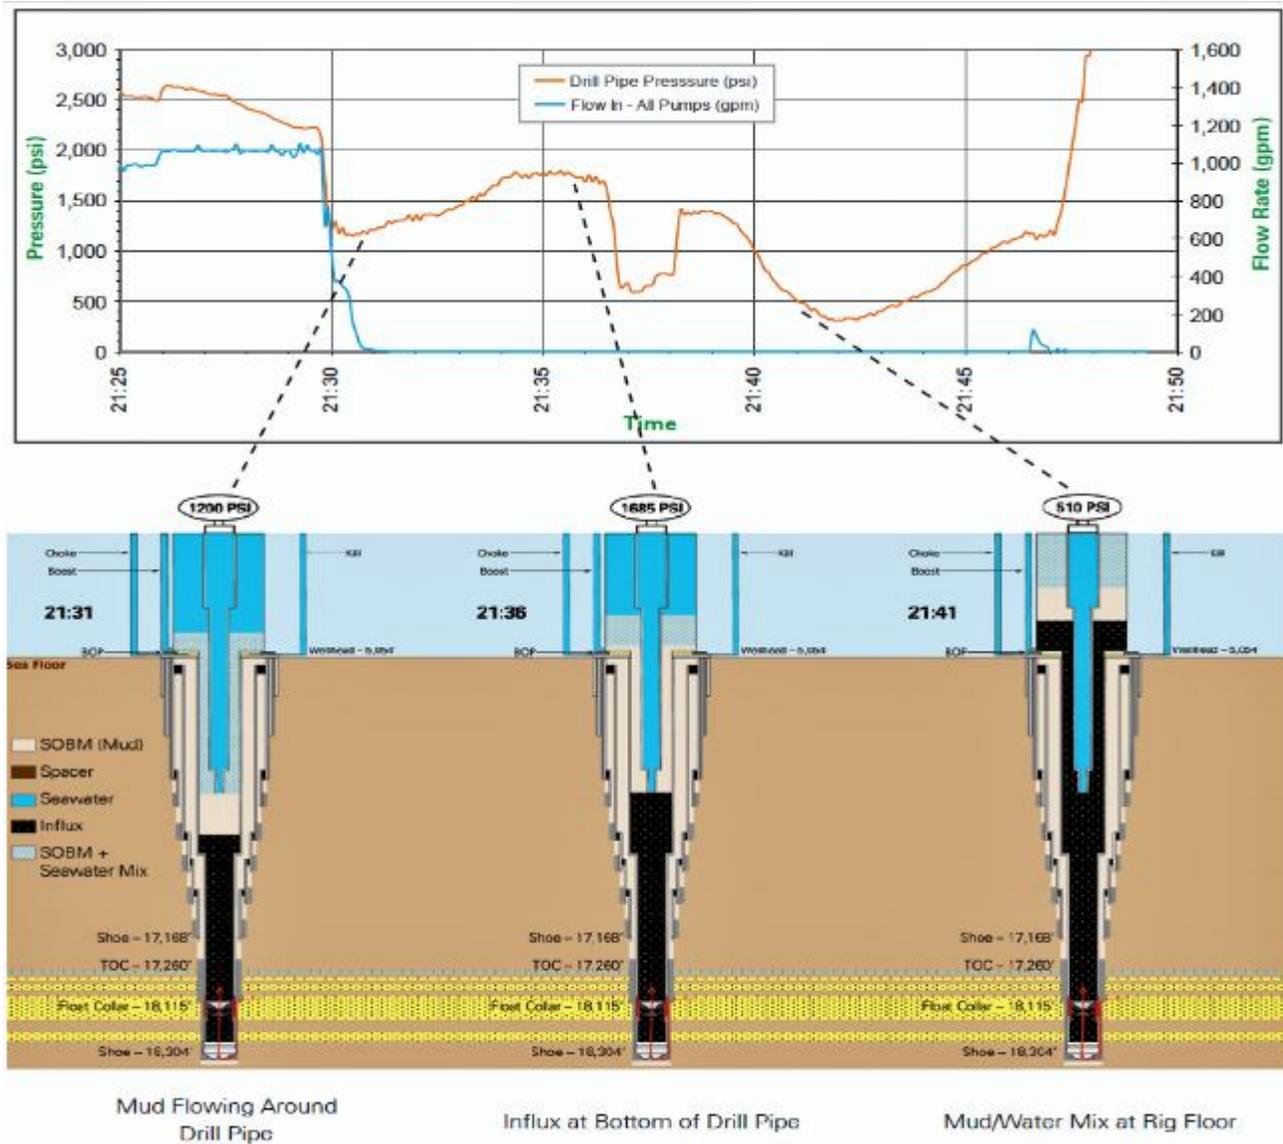
Figure 16. Modeled Pressure Responses Resulting from Hydrostatic Changes in the Wellbore.

Ingreso de HC al pozo

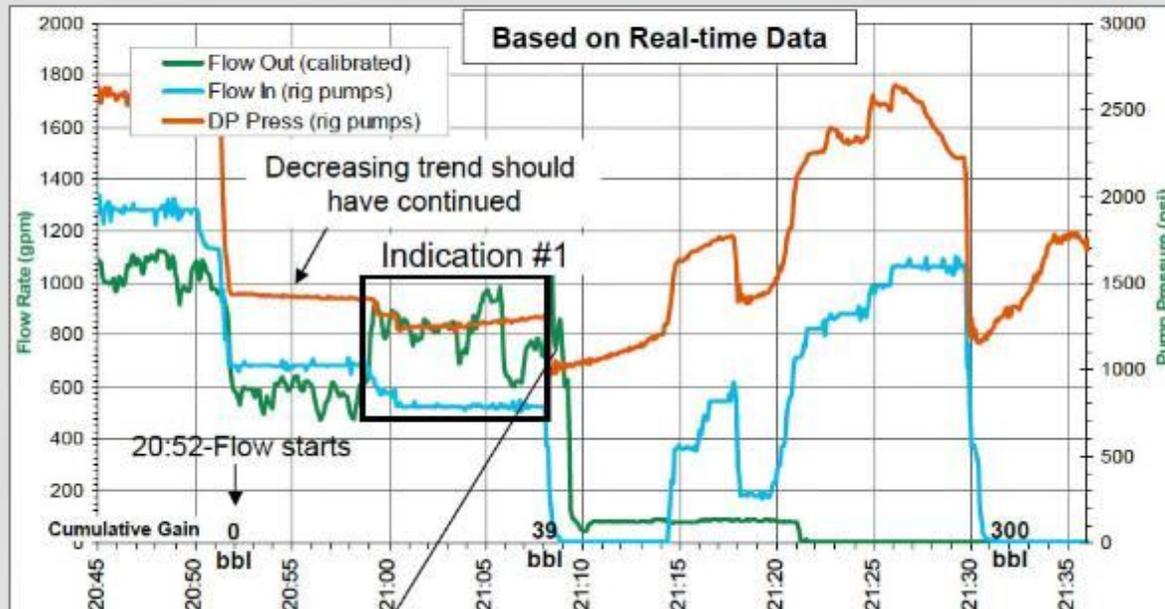
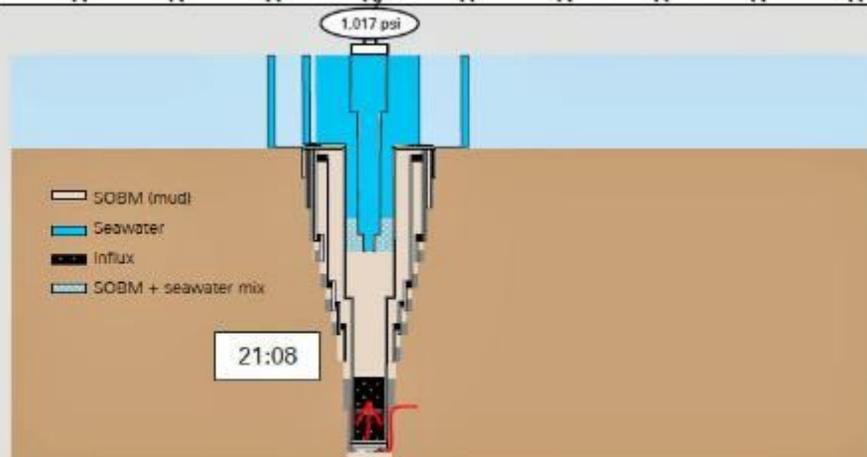
The influx was not recognized until hydrocarbons were in the riser

- #1: Drill pipe pressure increased by 100 psi, (expected decreased); ~39 bbl gain from 20:58 to 21:08

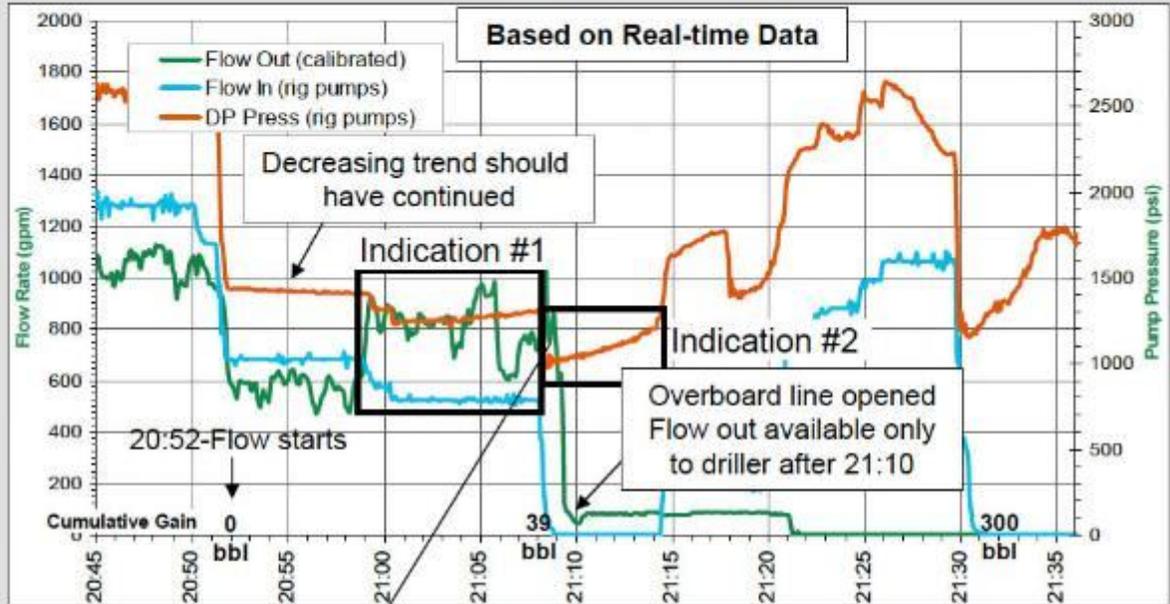
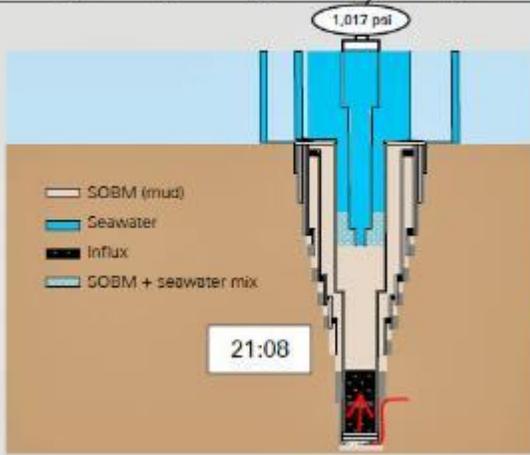
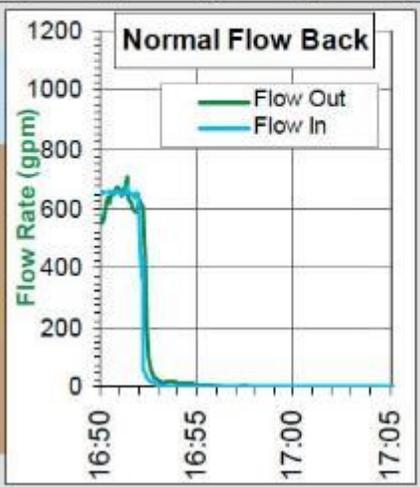
The influx was not recognized until hydrocarbons were in the riser

- #1: Drill pipe pressure increased by 100 psi, (expected decreased); ~39 bbl gain from 20:58 to 21:08
- #2: Drill pipe pressure increased by 246 psi with pumps off
 - Flow out does not immediately drop after shutting down pump

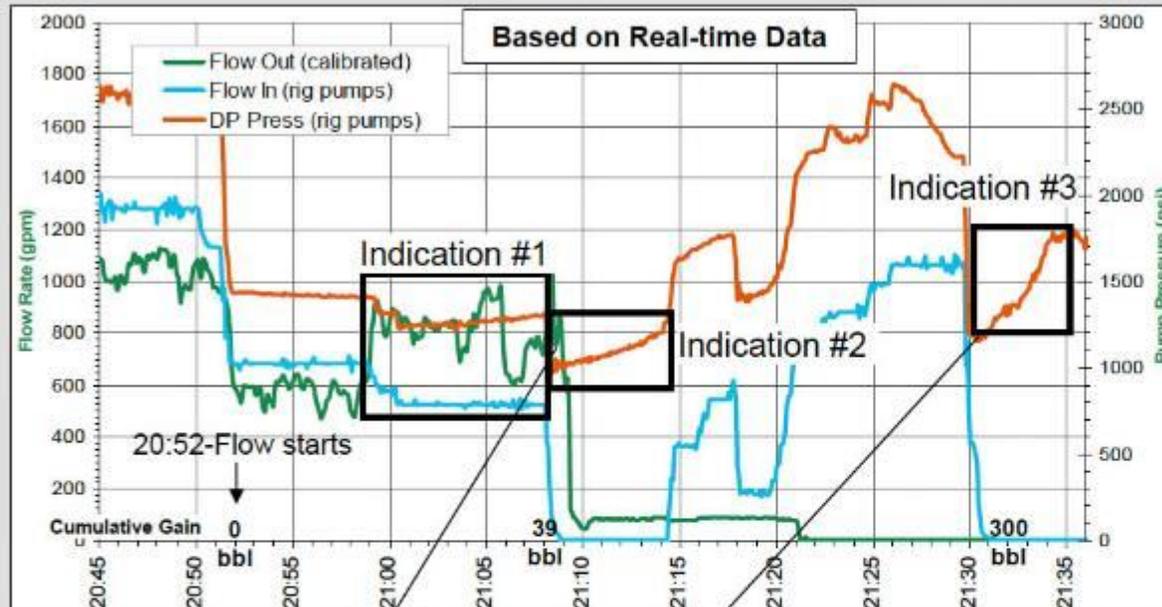
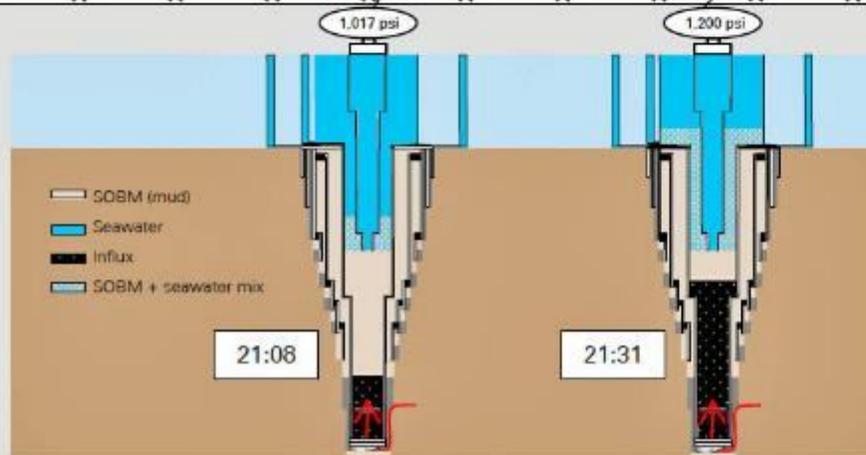
The influx was not recognized until hydrocarbons were in the riser

- #1: Drill pipe pressure increased by 100 psi, (expected decreased); ~39 bbl gain from 20:58 to 21:08
- #2: Drill pipe pressure increased by 246 psi with pumps off
 - Flow out does not immediately drop after shutting down pump
- #3: Drill pipe pressure increased by 556 psi with pumps off; ~300 bbl gain

- No well control actions taken

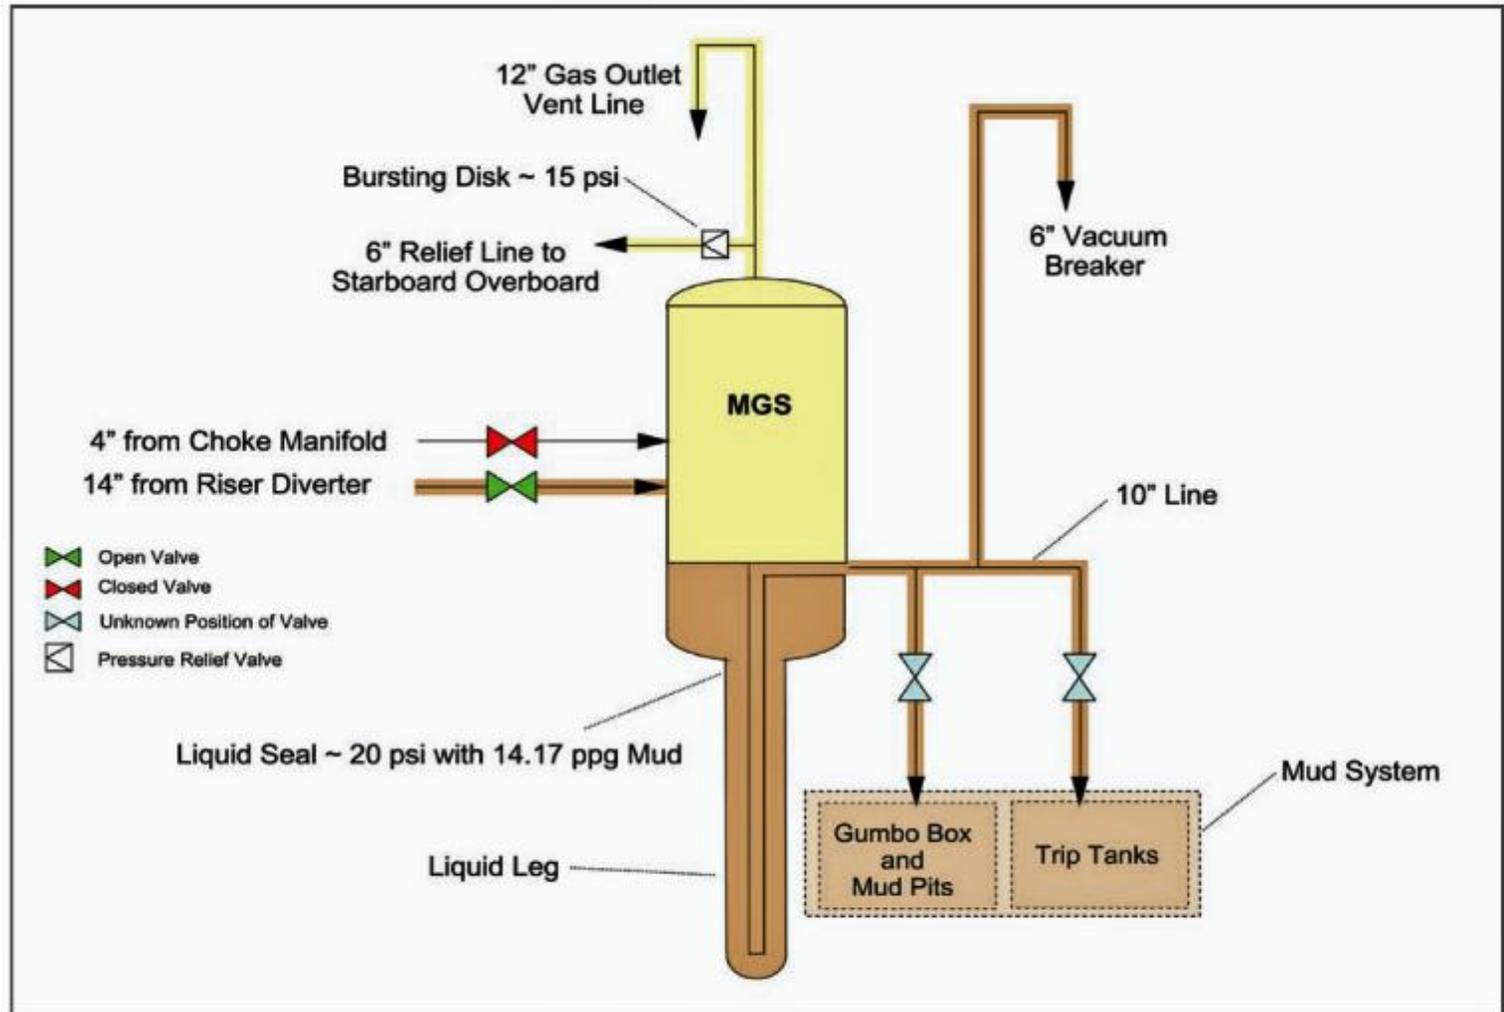
Figure 5. Mud Gas Separator.

The MGS removes only small amounts of gas entrained in the mud. Once separated, the gas is vented to the atmosphere at a safe location. When the rig crew diverted high flow to the MGS, the system was overwhelmed.

The investigation team concludes that, at approximately 21:41 hours, the rig crew diverted the flow of hydrocarbons to the MGS. (Refer to Figure 5.) The MGS is a low-pressure system, and its design limits would have been exceeded by the expanding and accelerating hydrocarbon flow. The main 12 in. gas outlet vent from the MGS was goosenecked at its terminus on top of the derrick, and it vented gas down onto the rig. Several other flow-lines coming from the MGS vessel directed gas onto the rig and potentially into confined spaces under the deck.

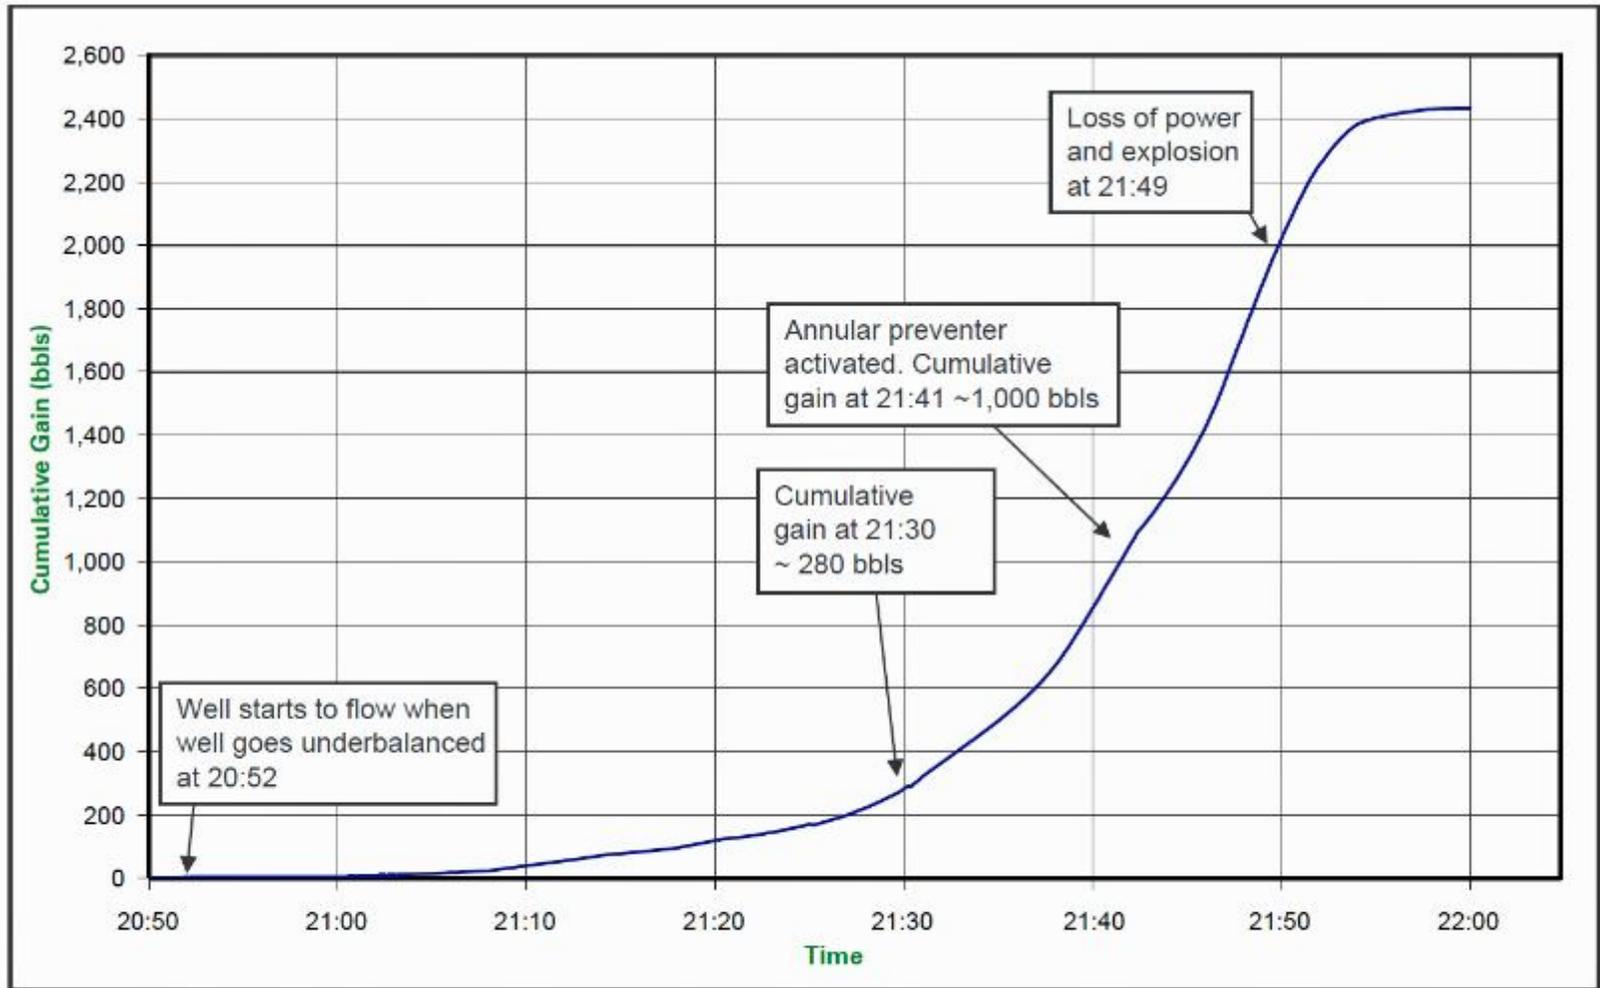
Figure 18. OLGA[®] Well Flow Modeling Prediction of Cumulative Gain Excluding Pumped Volumes 20:52 Hours–21:49 Hours.

Influjo de HC acumulados en la última hora

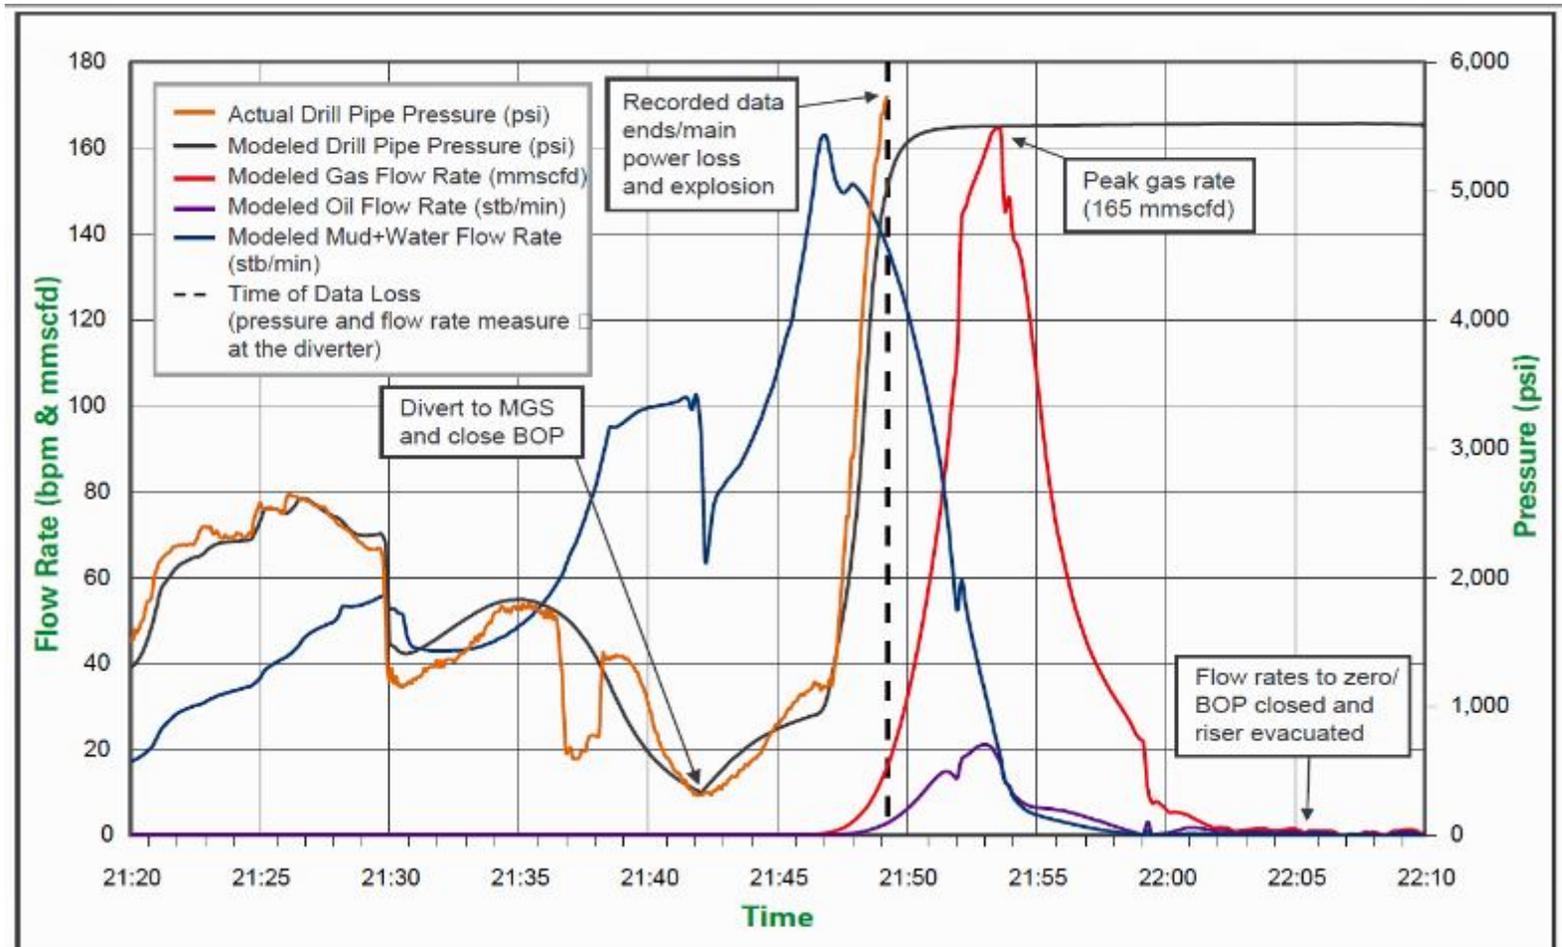
Figure 1. OLGA® Well Flow Modeling Prediction of Fluid Outflow from the Riser.

Time	Witness Accounts	
~21:40 hours	Mud flowed across the rig floor and down the outside of the riser to the sea	
~21:41 hours	Mud shot up to the crown block	
~21:41 hours	Diverted flow to the mud gas separator (MGS) and activated the blowout preventer (BOP)	
~21:44 hours	Mud flowed out of the MGS vent	
~21:46 hours	Gas vented to the atmosphere (very loud hissing)	
~21:47 hours	BOP sealed around the drill pipe	
~21:47 hours	Gas alarms activated on the fire and gas panel	
~21:48 hours	Engines started to overspeed	
21:49:15 hours	Power lost on <i>Deepwater Horizon</i>	Anchor Point
21:49:20 hours	First explosion	
21:49:30 hours	Second explosion

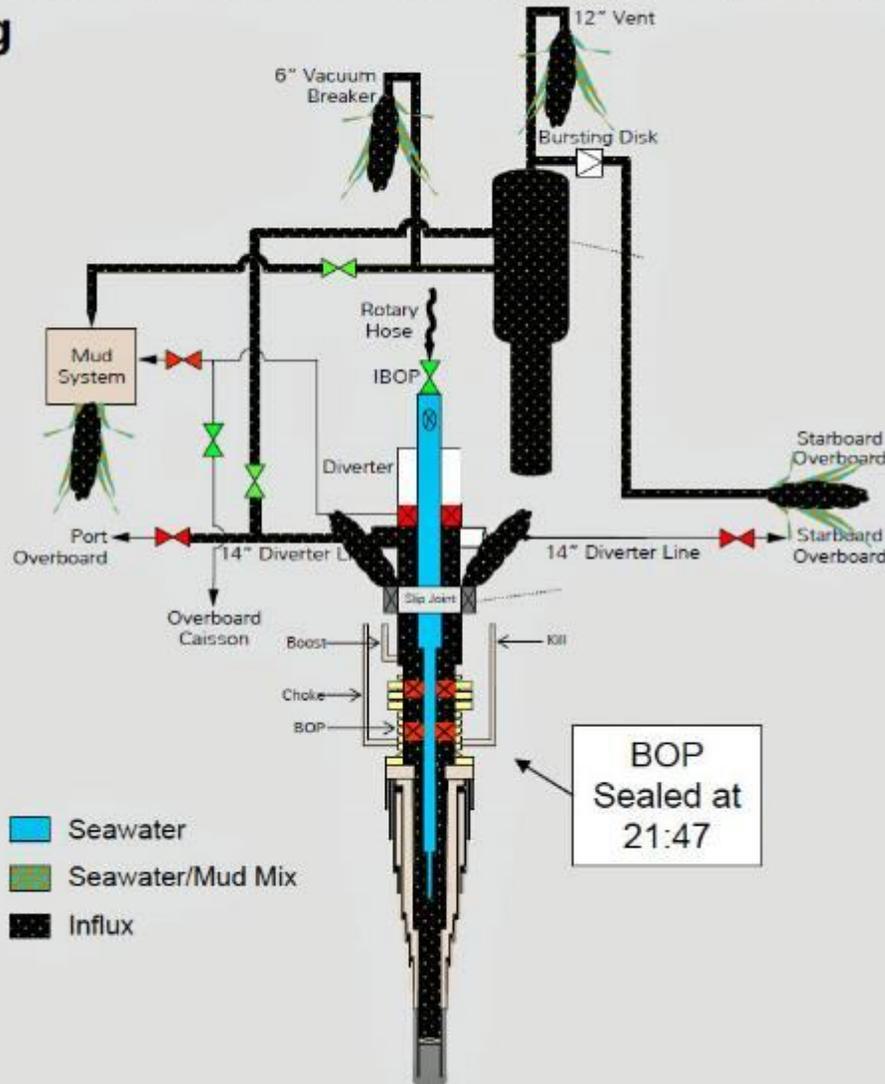
Diversion to the mud gas separator resulted in gas venting onto the rig

- Hydrocarbons were routed to the mud gas separator instead of diverting overboard
- Resulted in rapid gas dispersion across the rig through the MGS vents and mud system

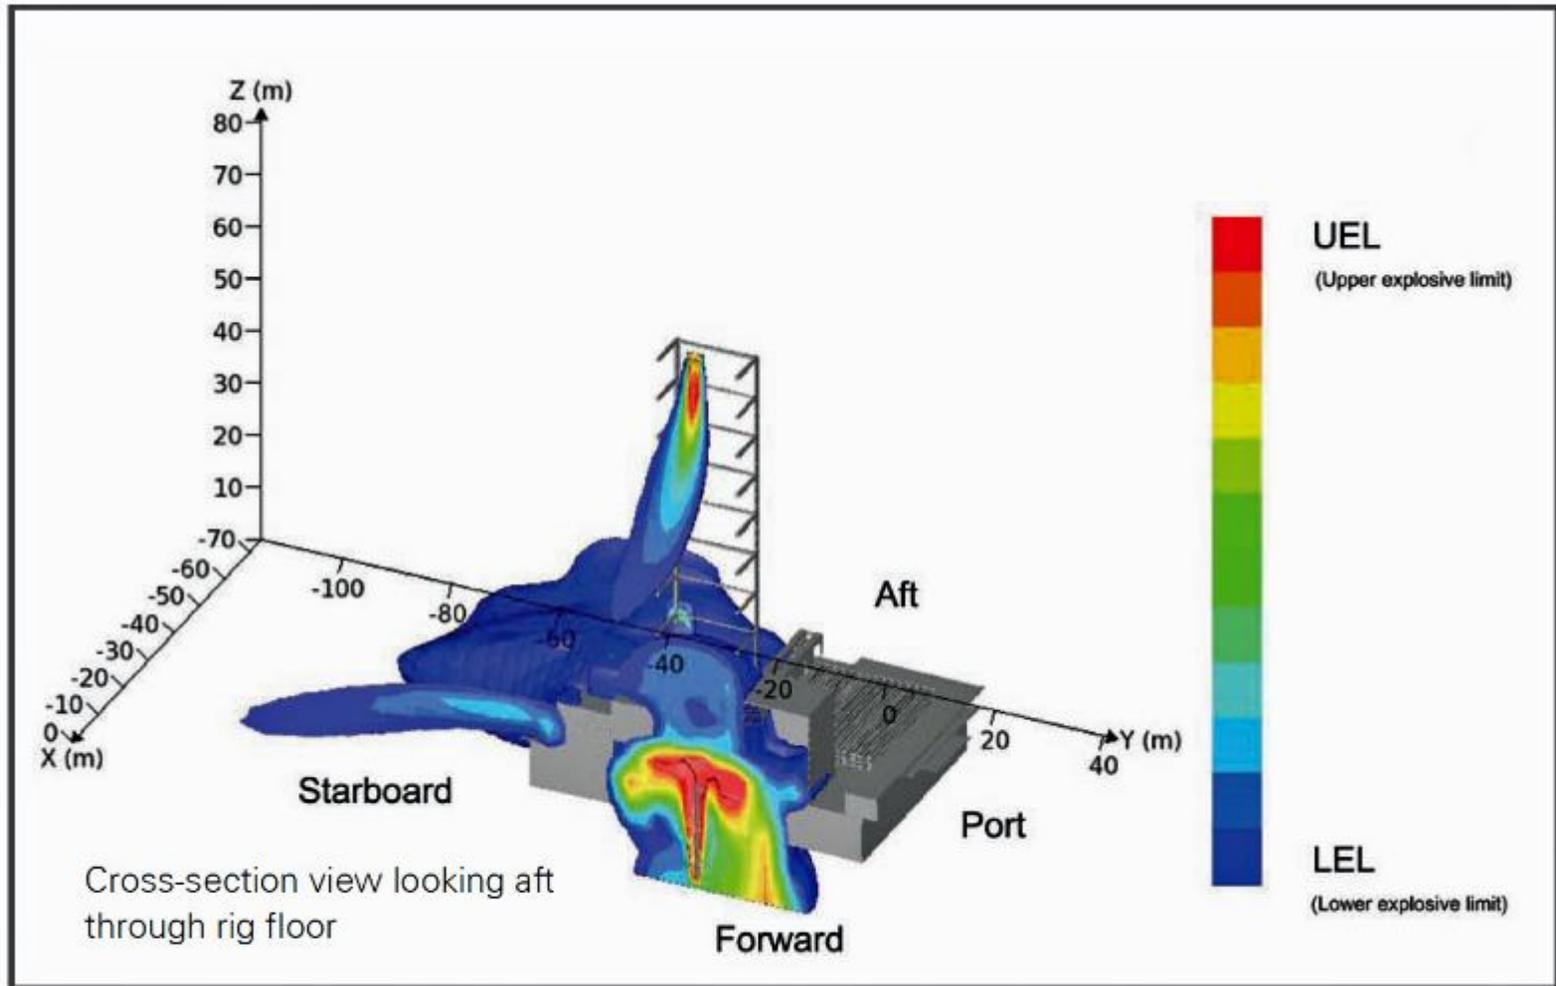
Figure 10. Vapor Dispersion at 240 Seconds.

Modelado de dispersión del gas

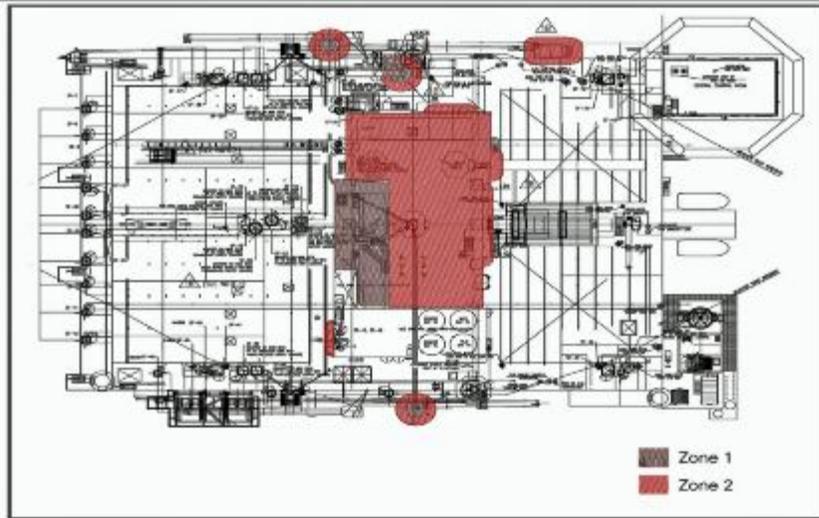
Figure 17. Hazardous Area Classification—Main Deck.

Vista general- Análisis de la ignición de los HC

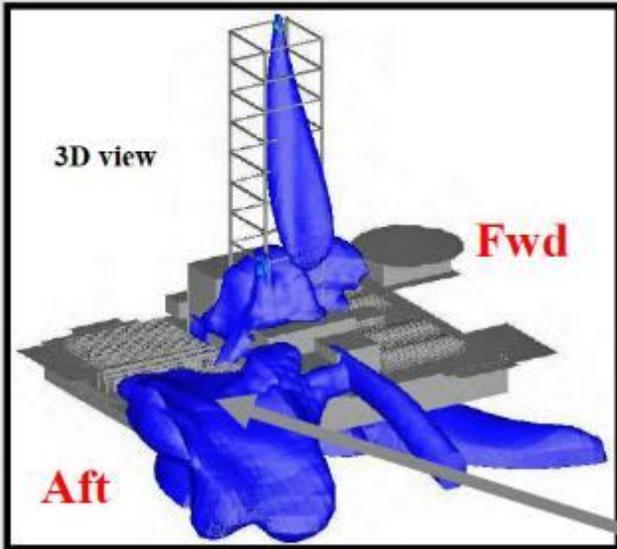
Secondary protective systems are designed to reduce the potential consequence of an event once the primary protective systems have failed.

- Gas cloud reached the supply air intakes for engine rooms 3, 4, 5 & 6
- The Fire and Gas system did not automatically trigger a shutdown of the HVAC system for the engine rooms
- Limited areas of the rig are designated as electrically classified zones

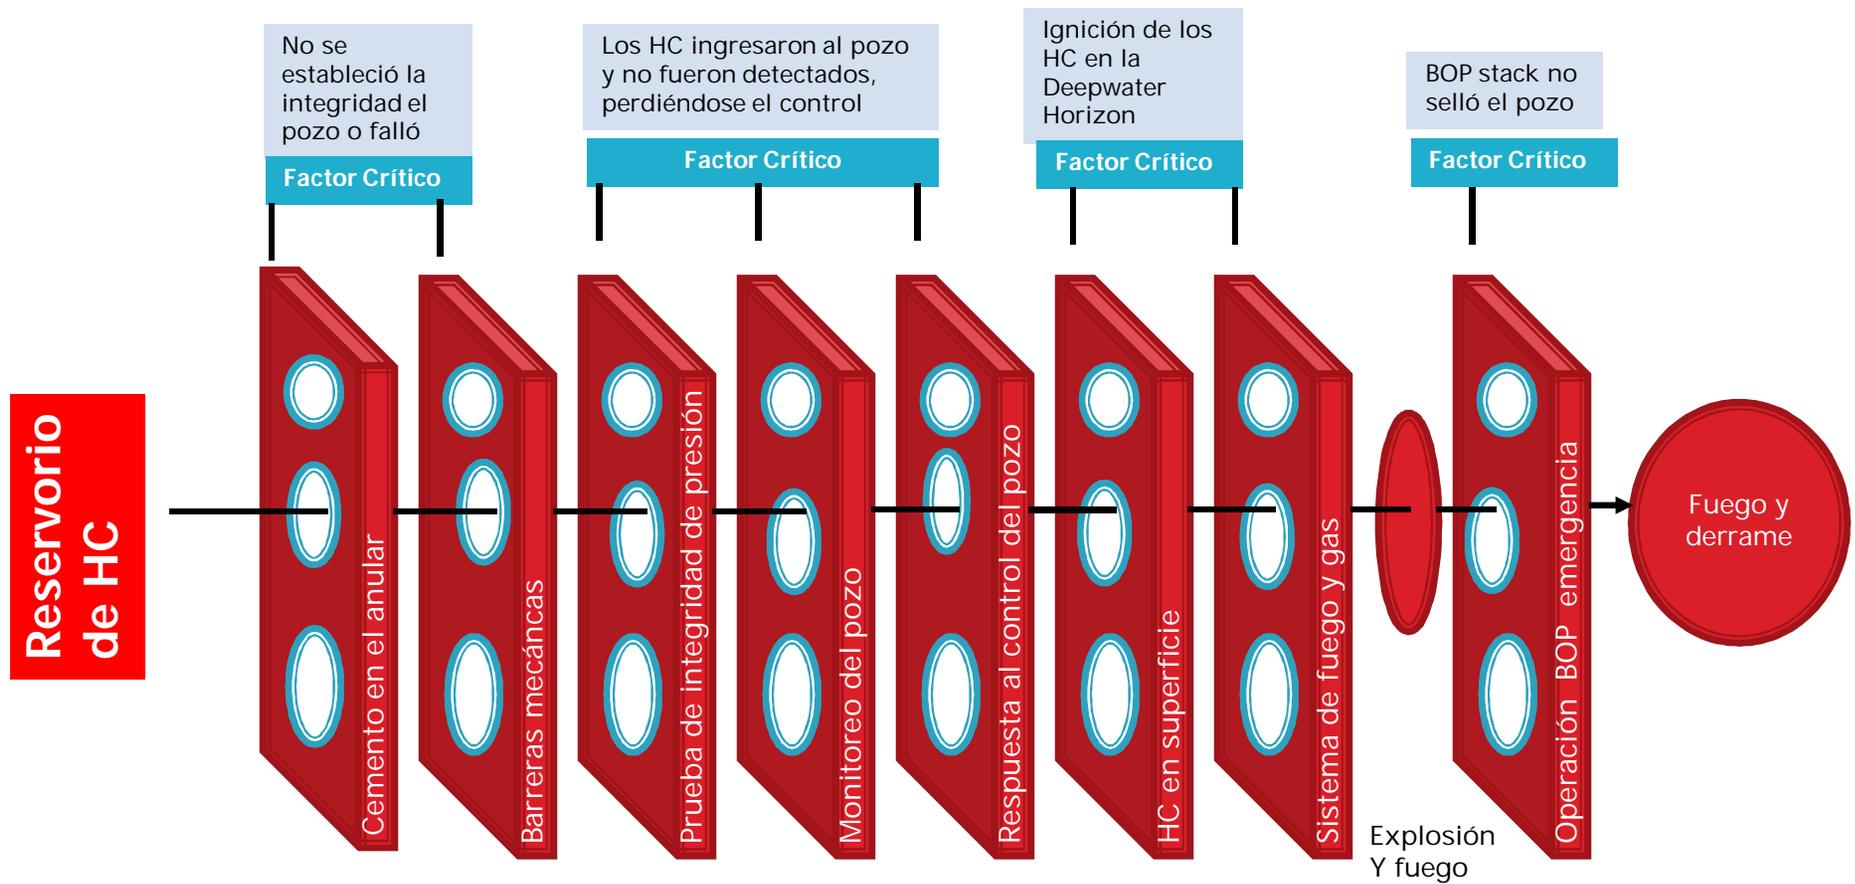
Figura 1. Barreras que no funcionaron y la relación de las barreras con los factores críticos.

Key Finding 8. The BOP emergency mode did not seal the well.

None of the emergency methods available for operating the BOP were successful in isolating the wellbore. The different methods available were not fully independent; therefore, single failures could affect more than one emergency method of BOP operation. Ultimately, the only way to isolate the well at the BOP was to close a single component, the blind shear ram (BSR); that ram had to shear the drill pipe and seal the wellbore.
