Deep Water Horizon Lecciones Aprendidas

Un Reporte de lo ocurrido con la Deepwater
Horizon

En la noche del 20 de abril del 2011, un evento de Well Control permitió que los hidrocarburos salieran del pozo Macondo sobre el semisumergible Deepwater Horizon de la empresa Transocean, resultando en explosiones y fuego en el equipo. 11 personas perdieron la vida, y otras 17 resultaron heridas. El fuego, que fue alimentado por los hidrocarburos que salieron del pozo continuó por 36 horas hasta que el equipo se hundió. Los hidrocarburos continuaron saliendo por el BOP por 87 días, causando un derrame de significancia mundial.

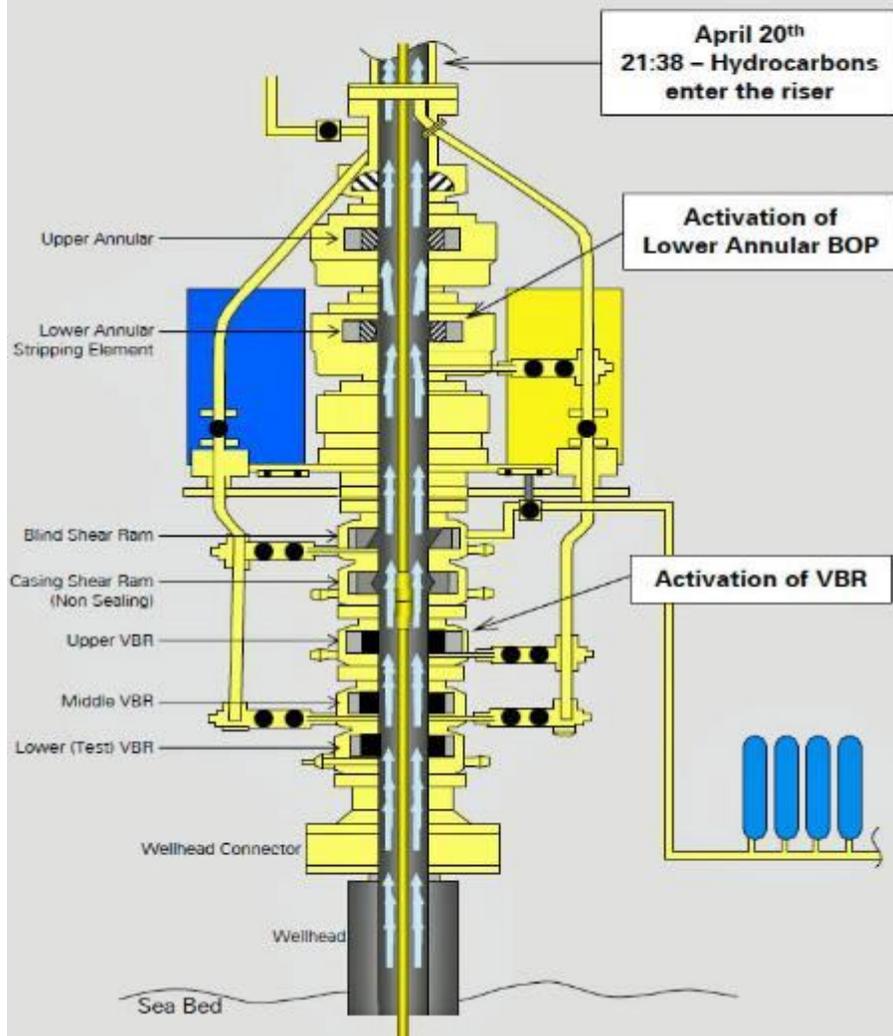
BOP Response (Before the Explosions)

BOP is designed to seal the wellbore and shear casing or drill pipe if necessary.

- Damage to MUX cables and hydraulic line
 - Opening of annular BOP
- Rig drifted off location
 - Upward movement of the drill pipe in the BOP

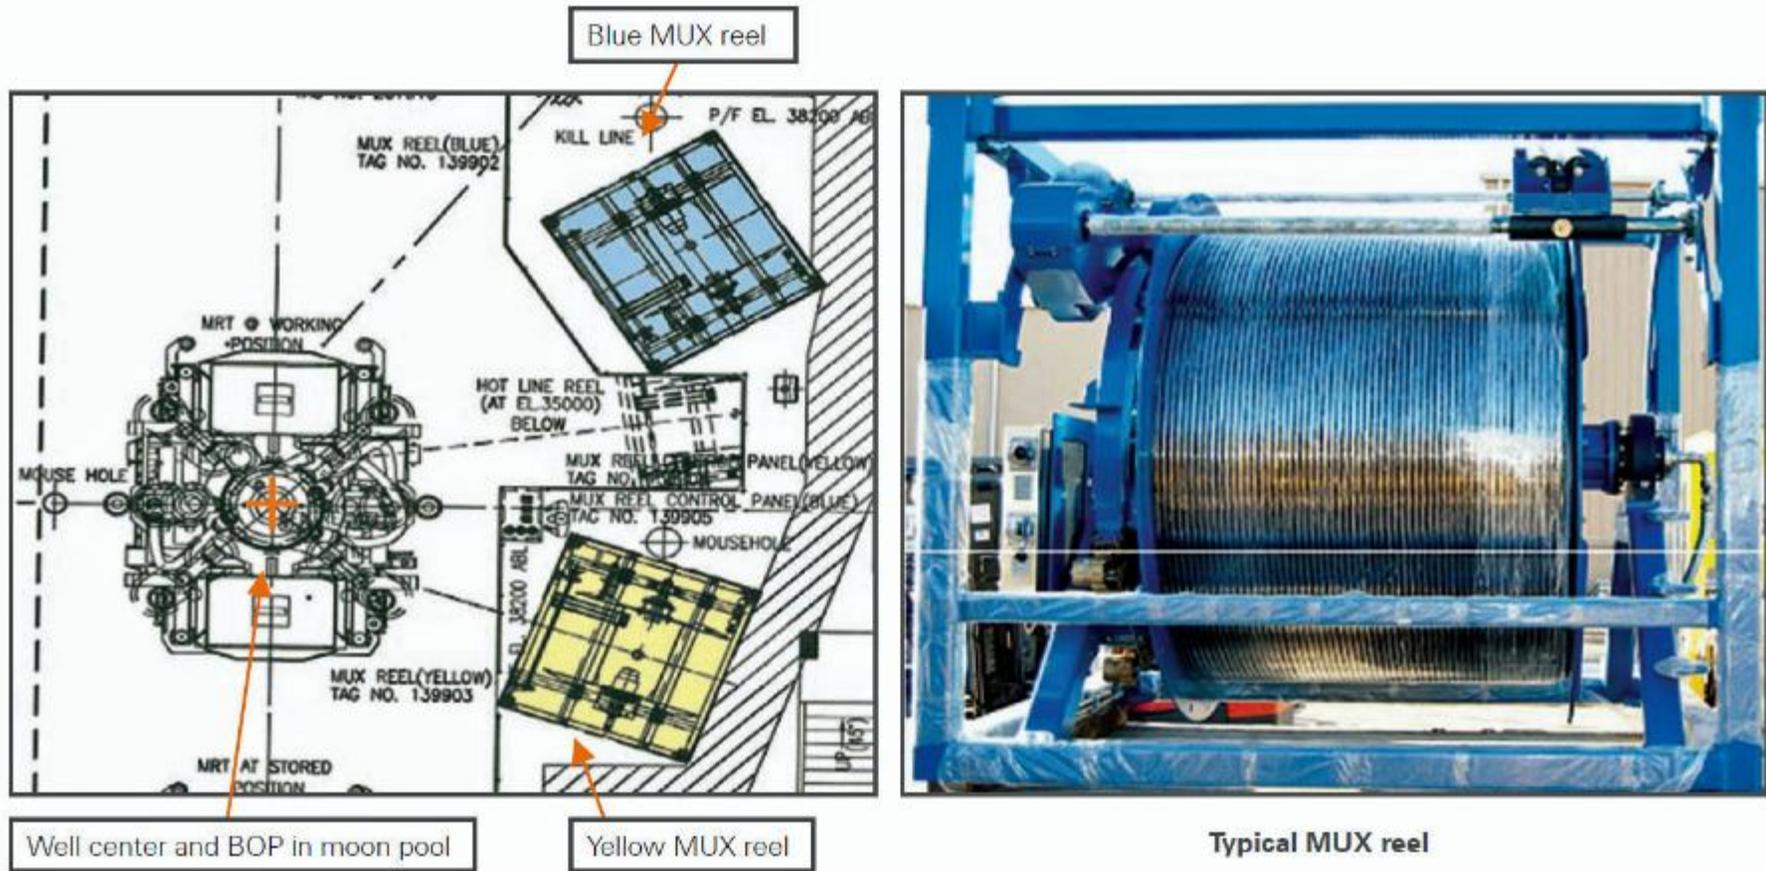
Figure 6. Moon Pool Layout Showing the Location of Blue and Yellow MUX Reels.

- The explosions and fire very likely damaged the MUX cables, disabling the two emergency methods of BOP operation available to rig personnel: the high-pressure BSR operation and EDS capability. The MUX cables/reels were located in the moon pool and had little or no resistance to explosion and fire.
- The AMF initiation conditions (failure of MUX cables and hydraulic lines) would have been met soon after the first explosion. However, it is unlikely that the AMF sequence could have been completed by either control pod, due to the failed solenoid valve 103 in the yellow pod and an insufficient charge on the 27-volt AMF battery bank in the blue pod.
- The ROV actuation of the autoshear function appeared to close the BSR but failed to seal the wellbore.

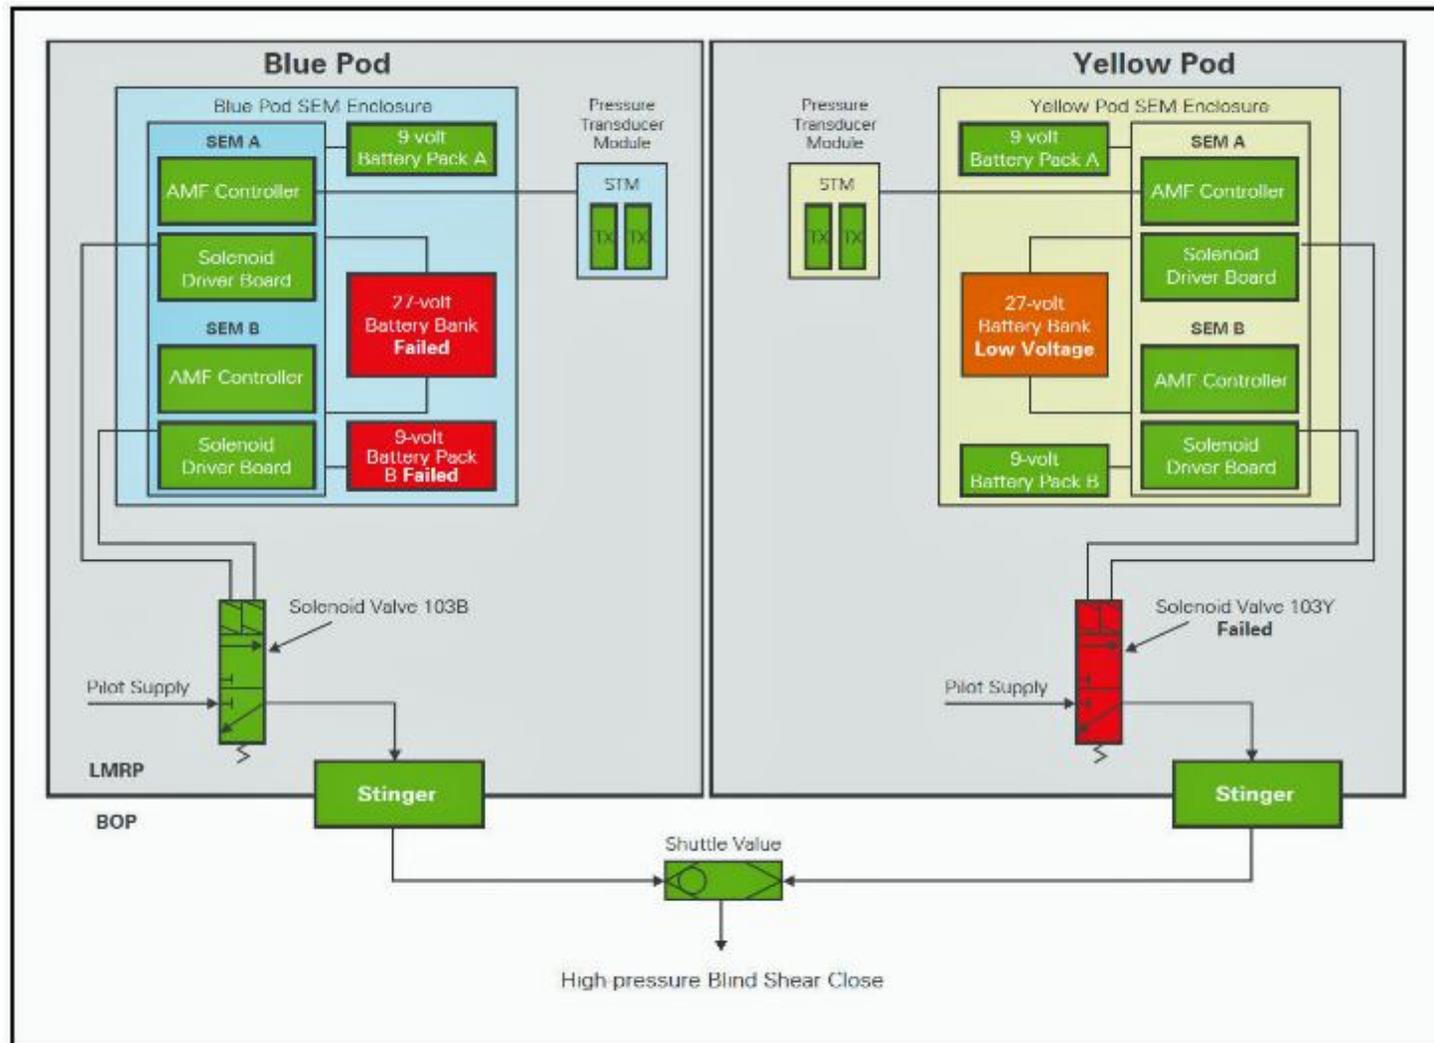
Figure 8. Simplified Schematic of the AMF Control System.

Fallas en el Sistema de control del BOP

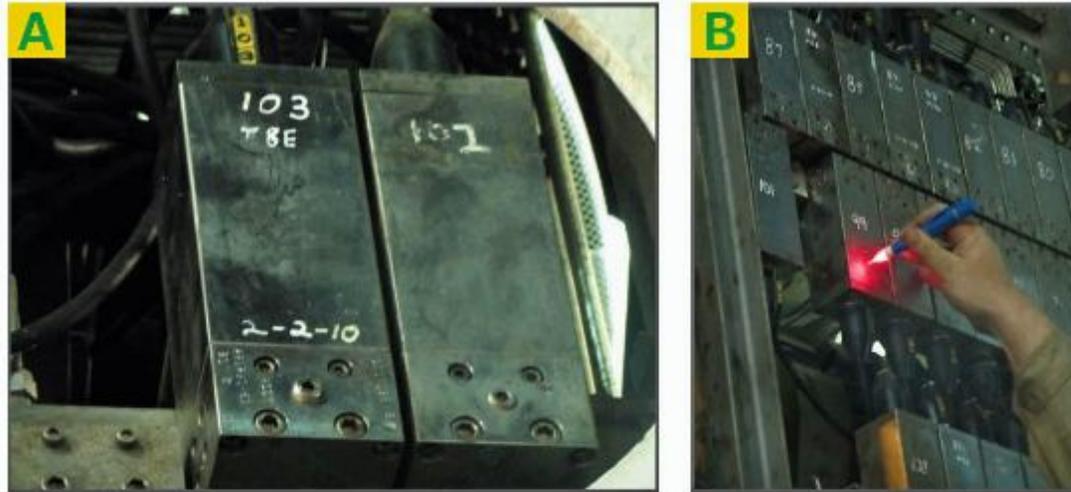
Figure 16. (A) Photograph of Solenoid Valve 103 in the Yellow Pod. **(B)** Testing of Solenoid Coils.

BOP Critical Faults– Yellow Solenoid– Blue Battery Pack

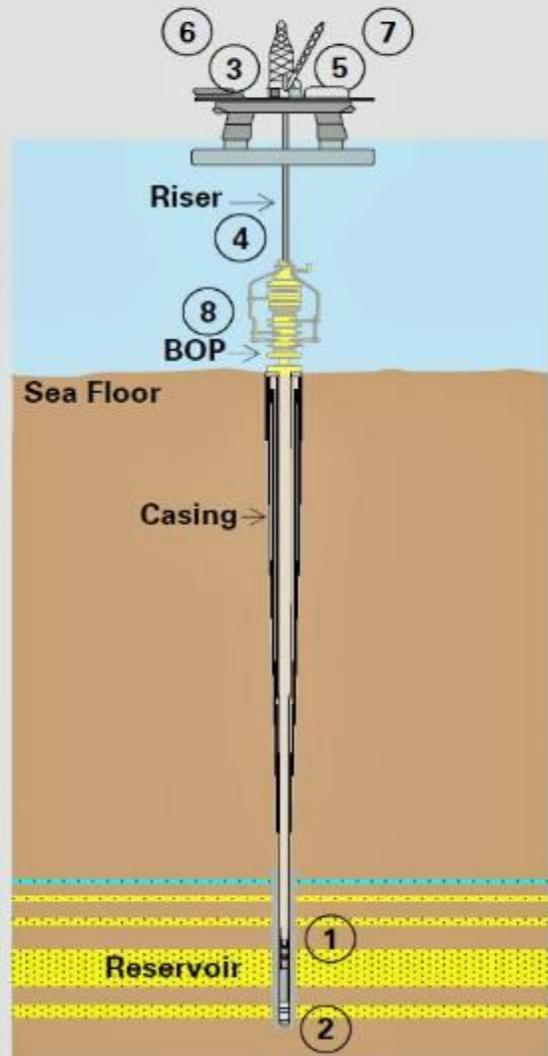
Eight Barriers Were Breached

I. Well integrity was not established or failed

- ① Annulus cement barrier did not isolate hydrocarbons
- ② Shoe track barriers did not isolate hydrocarbons

- ③ Negative pressure test was accepted although well integrity had not been established
- ④ Influx was not recognized until hydrocarbons were in riser
- ⑤ Well control response actions failed to regain control of well
